Research Project Number TPF-5(193) Supplement #87

PLACEMENT OF BREAKAWAY LIGHT POLES LOCATED DIRECTLY BEHIND MIDWEST GUARDRAIL SYSTEM (MGS)

MIDWEST ROADSIDE SAFETY FACILITY

MwRSF Research Report No. TRP-03-361-17

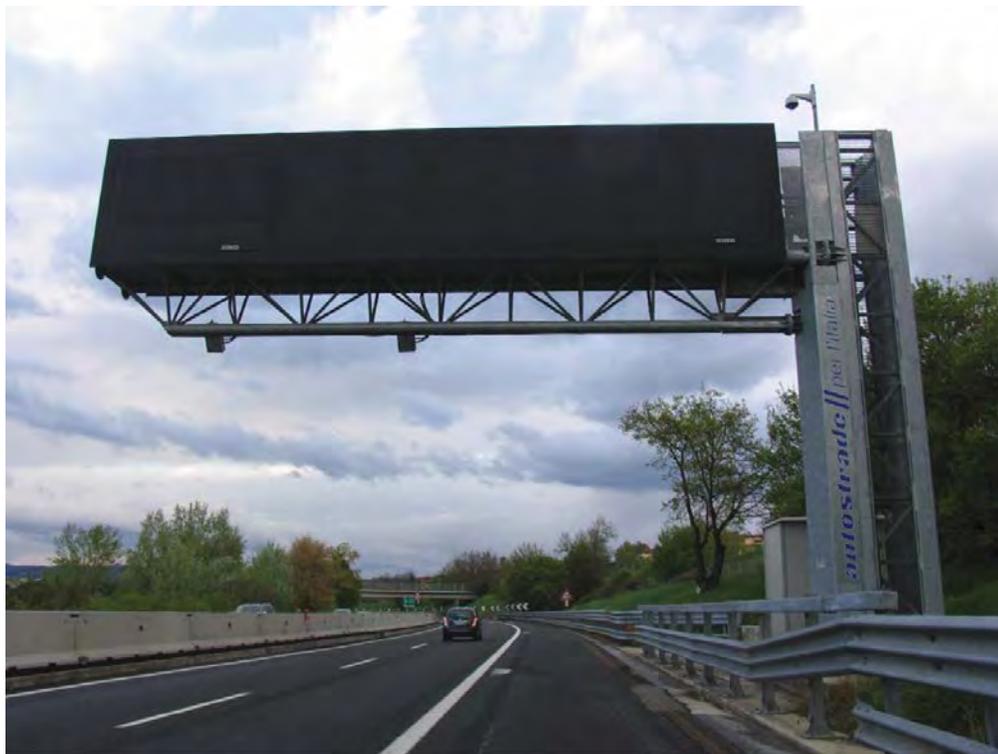
Figure 6. Sign Support and Guardrail

A project evaluating the safety performance of a sign support and guardrail system was completed by the Civil and Environmental Engineering Department at the University of Florence in Firenze, Italy in 2014 [16]. A variable message sign (VMS) with a non-breakaway sign support structure and an H3 steel barrier, as shown in Figure 6, were evaluated using finite element method (FEM) simulations and no crash testing. The objectives of the study were to evaluate heavy vehicle and sign support interaction as well as determine minimum lateral offset between sign support and barrier.

Initially, three separate models were created: a barrier; a heavy vehicle; and a sign support structure. The barrier model was evaluated and validated by a full scale crash test. The sign support structure model for this test included a VMS spanning a three lane motorway with an emergency lane and traditional sign supports made of high-strength steel (S355JO). Only the parts bearing the highest stress during the crash of the sign support were included in the model due to the complexity of the design. A 35,274-lb (16,000-kg) infinitely rigid cube with a 9.84-ft x 9.84-ft (3-m x 3-m) cross section was used to simulate a heavy goods vehicle (HGV) with an

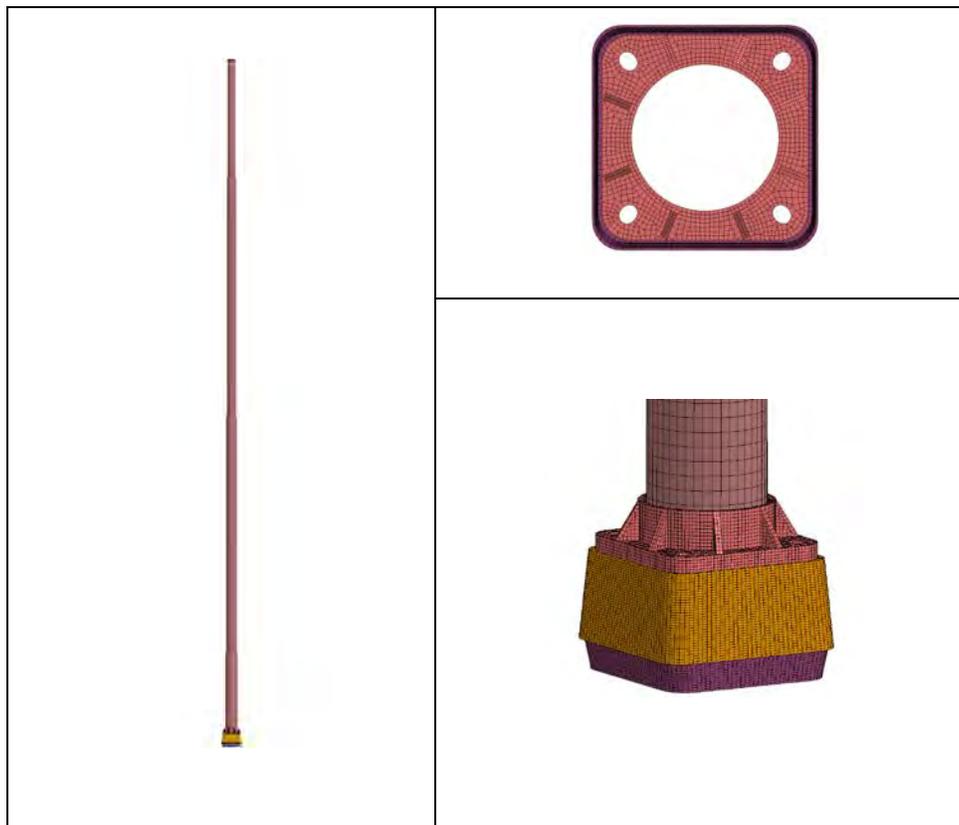
Figure 11. Computer Model of Pole and Base

Computer models of a 50-ft (15.25-m) tall pole with a 9-in. (228-mm) tall base were generated using a fine mesh, as shown in Figure 11. An automatic, single-surface contact was provided for the pole, vehicle, and MGS contact. In the LS-DYNA simulations, the pole and base were modeled as rigid parts that were constrained in all directions using MAT_RIGID. Thus, the pole could not break away. Accurate modeling of the breakaway mechanism of the pole was out of the scope of this project. As such, this modification would lead to a more severe simulated impact as compared to the actual test and thus a more conservative pole placement. Also, the use of the rigid pole would still provide insight into the potential for barrier and vehicle interaction with the pole. The pole has a 10-in. (254-mm) diameter at the base and a 6-in. (152-mm) diameter at the top. Two aluminum material models were utilized to represent the pole and base. Material parameters are summarized in Table 13.

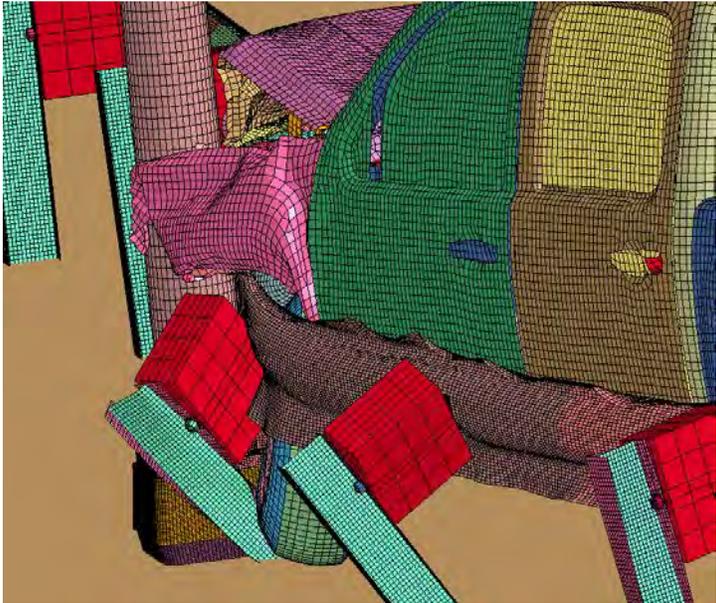
Figure 19. 2270P Vehicle Snag: (a) Fender Snag and (b) Wheel Snag

In simulations, two mechanisms for vehicle snag on the pole were identified: fender snagging (shown in Figure 19a), and wheel snagging (shown in Figure 19b). The wheel snag on the pole appeared to be responsible for increased vehicle instability and occupant risk values. In the simulations, the maximum lateral snag distance was greater for the fender snag as compared to the wheel. A maximum fender snag of 14 in. (356 mm) occurred, as shown in Figure 20. However, fender snag was likely overrepresented in the simulation due to the lack of pole fracture.

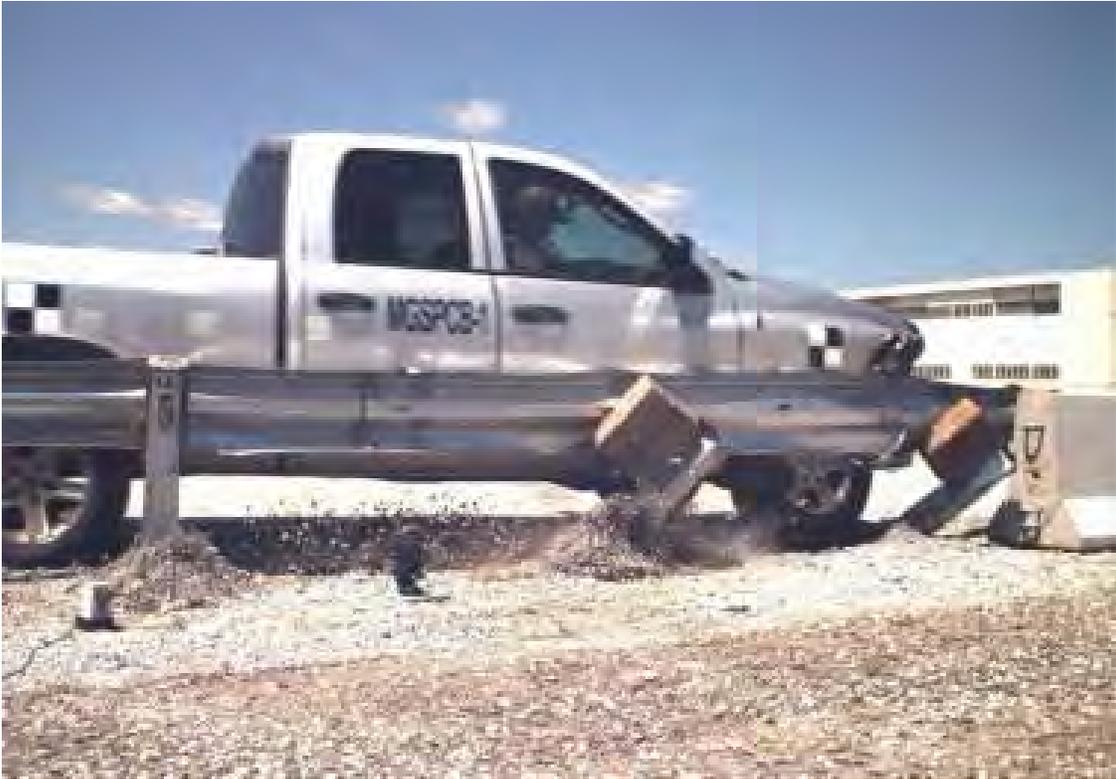
Figure 25. Test No. MGSPCB-1: (a) Post Contact with PCB and (b) Barrier Damage

Given a 20-in. (508-mm) lateral pole offset, it was necessary to determine the critical longitudinal pole offset. It was observed that the posts do not deform in the same manner in the crash tests and simulations. Therefore, previous testing of a MGS to portable concrete barrier (PCB) transition (test no. MGSPCB-1) was analyzed to determine more precise post deflection trajectories and interaction with obstacles [28]. In test no. MGSPCB-1, a 5,079-lb (2,304-kg) pickup truck impacted the PCB to MGS transition, as shown in Figure 24, at a speed of 63.2 mph (101.7 km/h) and at an angle of 25.3 degrees. In this test, one of the posts (post no. 16) twisted, bent downstream, and hit the end of the portable concrete barrier, as shown in Figure 25. Similar post interaction was expected to occur with the presence of a pole. The trajectory of post no. 16 in test no. MGSPCB-1 (that represents post no. 13 in the present evaluation study) was closely examined with respect to the candidate longitudinal pole offsets of 8, 12, 16, 20, and 24 in. (203, 305, 406, and 610 mm), as shown in Figure 26. The longitudinal pole offset away from post no. 13 was selected to ensure that the post would have the maximum engagement with the pole upon vehicle impact. Accordingly, a 20-in. (508-mm) lateral and 24-in. (610-mm) longitudinal pole offset away from post no. 13 was recommended for evaluation under MASH test designation no. 3-11, as shown in Figure 27. Sequential photographs of the simulation with recommended pole placement for test no. 3-11 are shown in Figure 28.

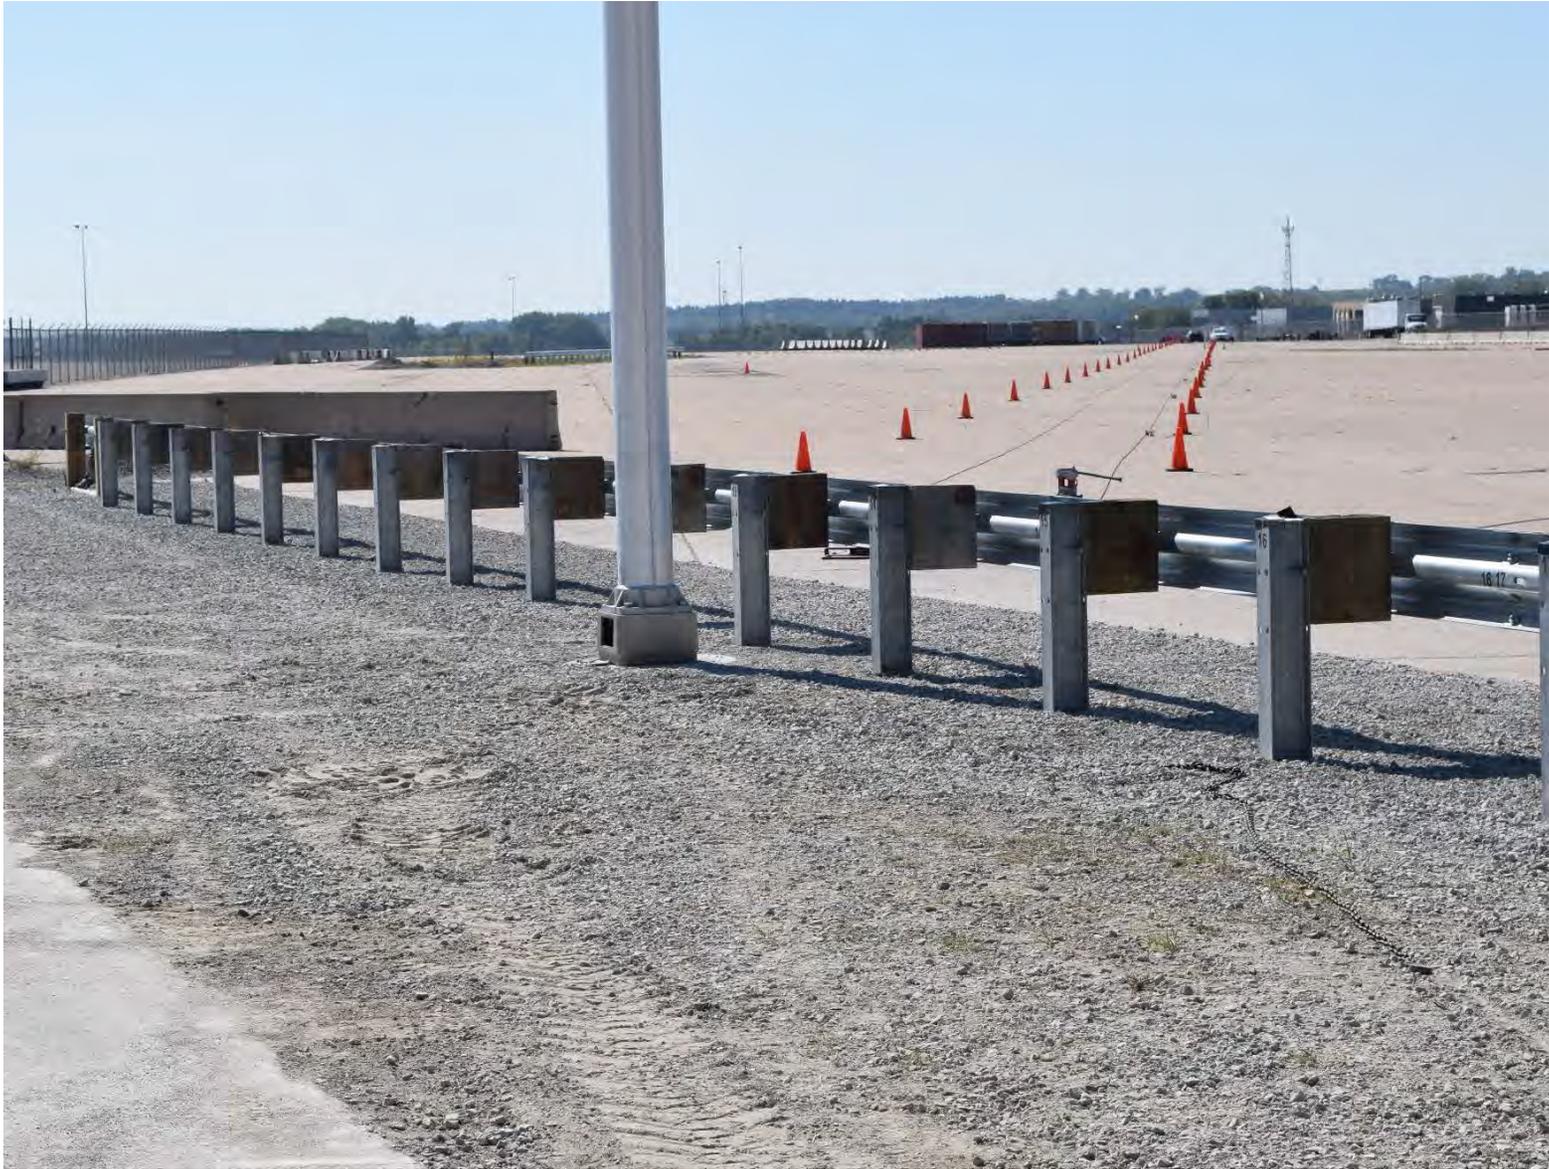
Figure 63. Test Installation, Test No. ILT-1

The W-beam guardrail system was comprised of 175 ft (53.25 m) of standard, 12-gauge (2.66-mm) thick W-beam rail segments supported by steel posts with a light pole placed 20 in. (508 mm) laterally behind the posts, as shown in Figure 35. End anchorage systems were used on both the upstream and downstream ends of the guardrail system. Design details are shown in Figures 35 through 62. Photographs of the test installation in a mirrored orientation are shown in Figures 63 through 66. Material specifications, mill certifications, and certificates of conformity for the system materials are shown in Appendix E.

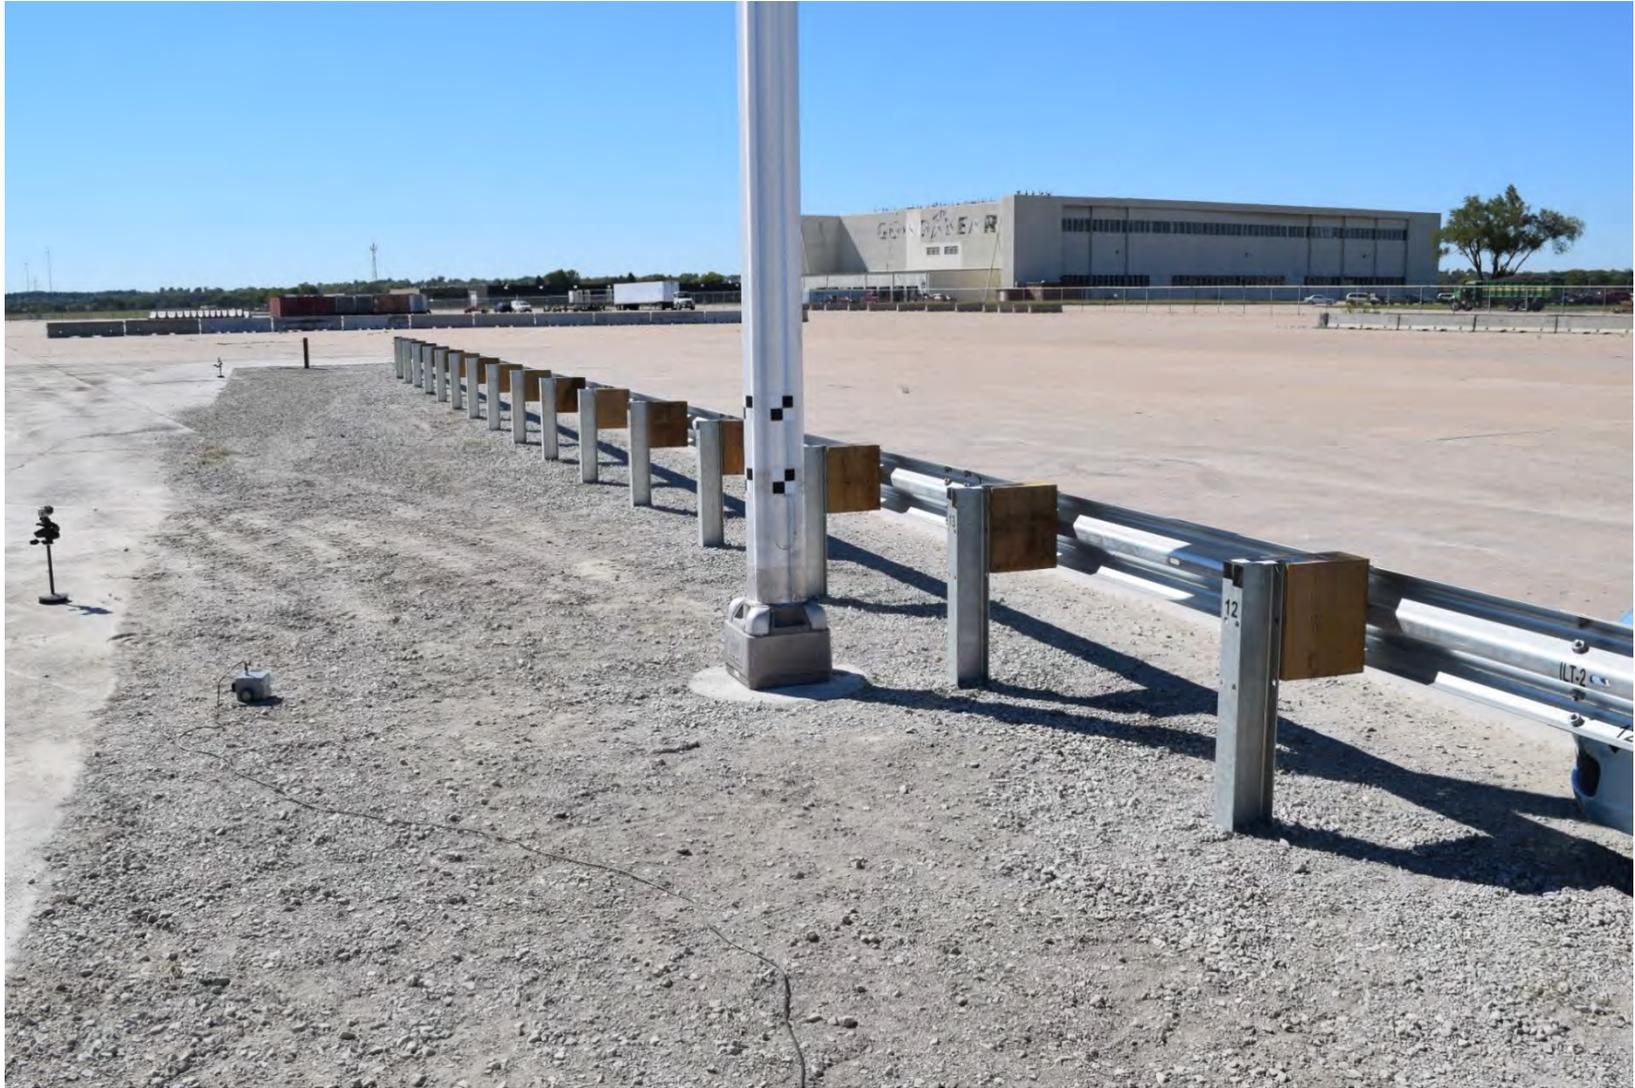
Figure 95. Test Installation, Test No. ILT-2

Similar to test no. ILT-1, test no. ILT-2 utilizes a 175-ft (53.3-m) MGS with a 50-ft (15.25-m) tall with a 15-ft (4.6-m) long mast arm light pole with 0.31-in. (8-mm) wall thickness as detailed in Figures 67 through 94. The weights of the pole shaft and arm mast were 474 lb (215 kg) and 55 lb (25 kg), respectively. Approximately 55 lb (25 kg) of steel plate was added to the end of the luminaire arm to simulate the luminaire weight. The total weight of the pole assembly was 584 lb (265 kg). The front face of the pole was offset 20 in. (508 mm) laterally behind the posts, and the centerline of the pole was offset 16 in. (406 mm) longitudinally downstream from post no. 13. Test no. ILT-2 was conducted on a barrier with a rail height of 32 in. (813 mm) to maximize potential vehicle underride and interaction with pole. Additional design details are shown in Figures 67 through 69. Photographs of the test installation are shown in Figures 95 through 98.

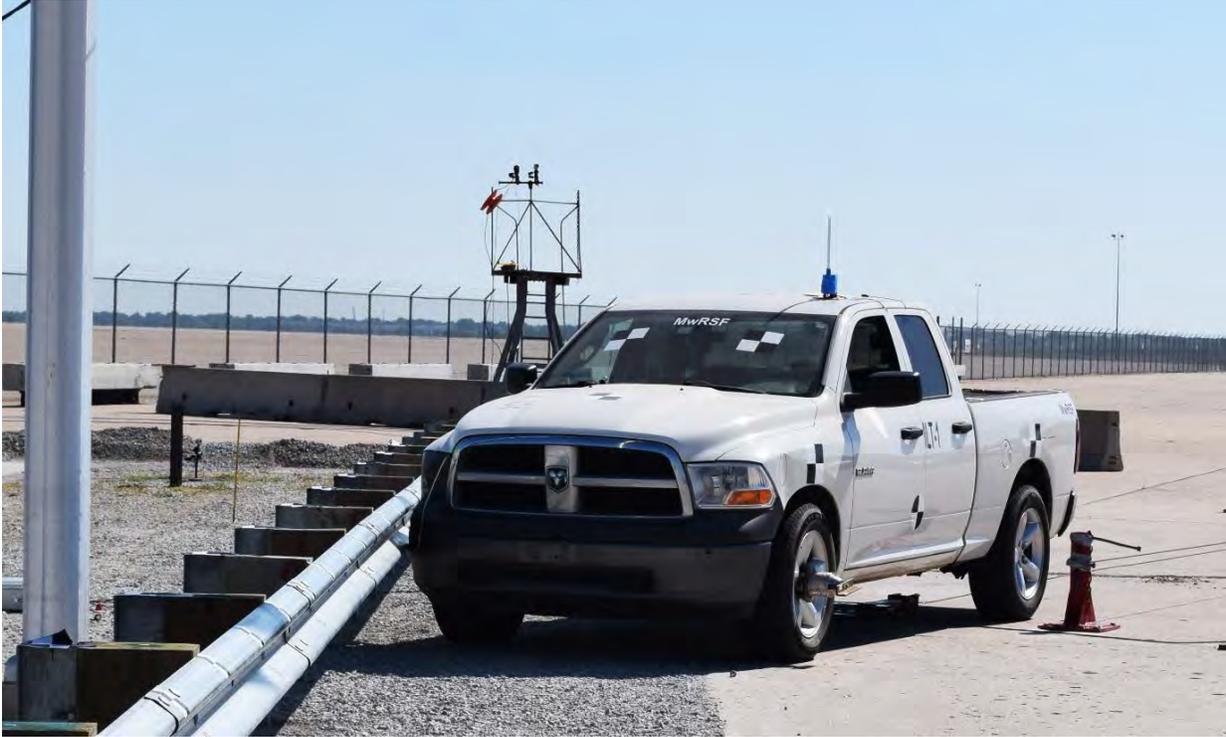
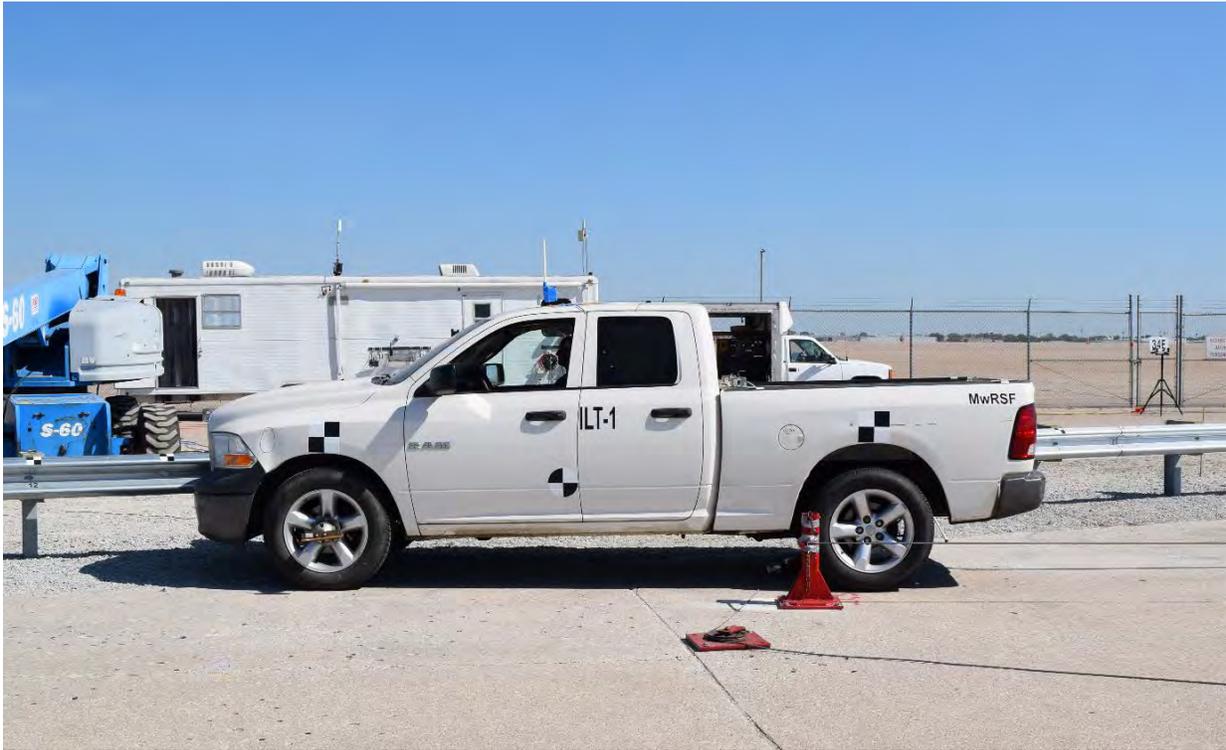
Figure 99. Test Vehicle, Test No. ILT-1

For test no. ILT-1, a 2009 Dodge Ram 1500 Quadcab was used as the test vehicle. This vehicle meets the requirements for a MASH 2270P pickup truck. The curb, test inertial, and gross static vehicle weights were 4,961 lb (2,250 kg), 5000 lb (2,268 kg), and 5,165 lb (2,343 kg), respectively. The test vehicle is shown in Figure 99, and vehicle dimensions are shown in Figure 100.

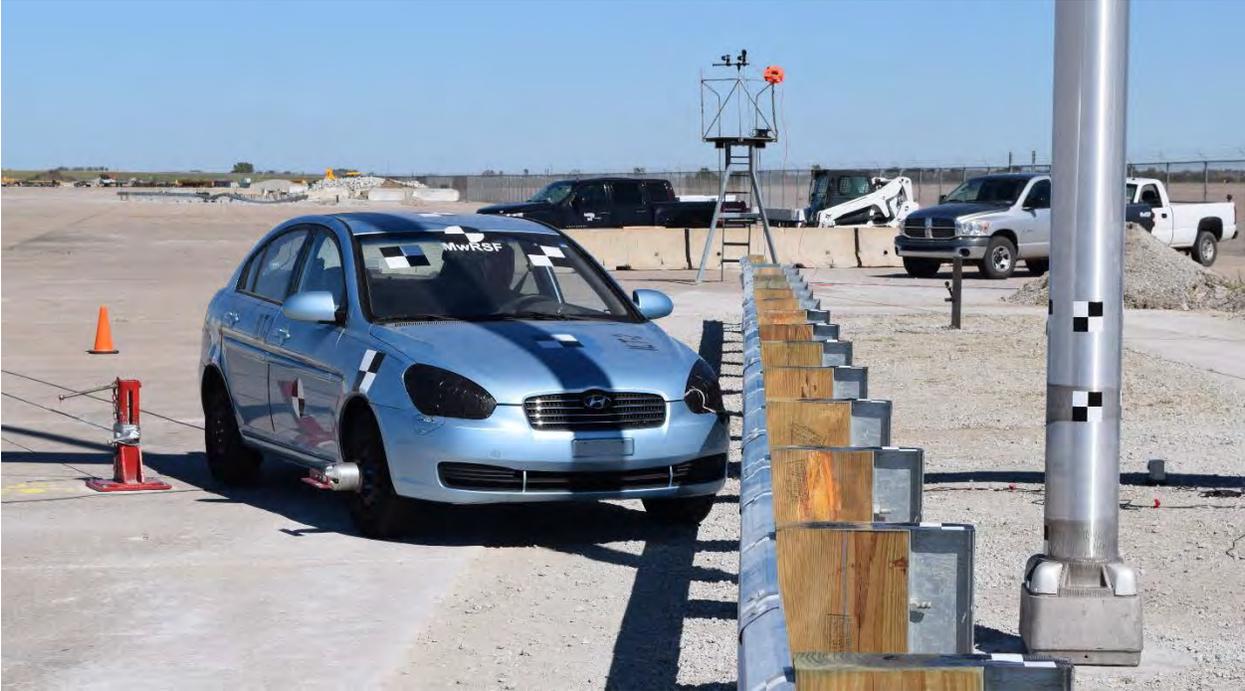
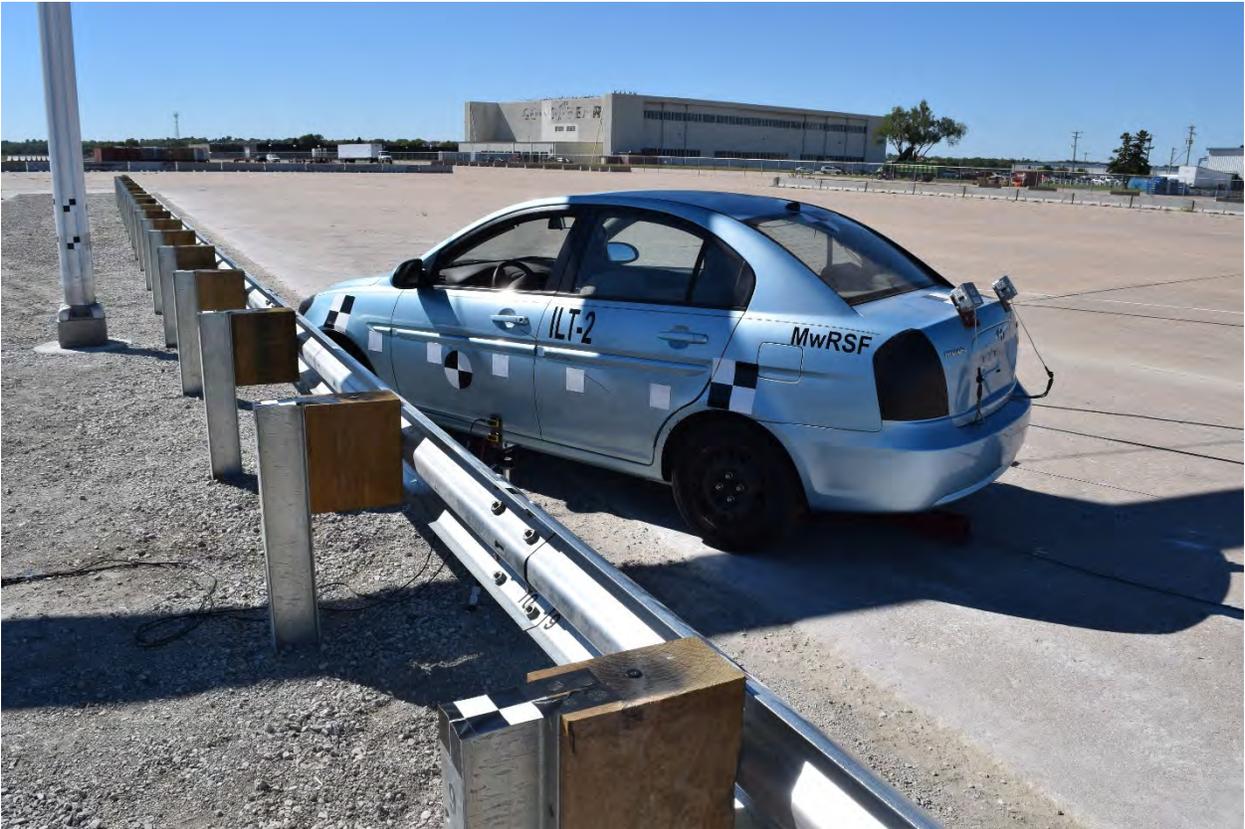
Figure 101. Test Vehicle, Test No. ILT-2

For test no. ILT-2, a 2009 Hyundai Accent was used as the test vehicle. This vehicle meets the requirements for a MASH 1100C passenger car. The curb, test inertial, and gross static vehicle weights were 2,434 lb (1,104 kg), 2,420 lb (1,098 kg), and 2,586 lb (1,173 kg), respectively. The test vehicle is shown in Figure 101, and vehicle dimensions are shown in Figure 102.

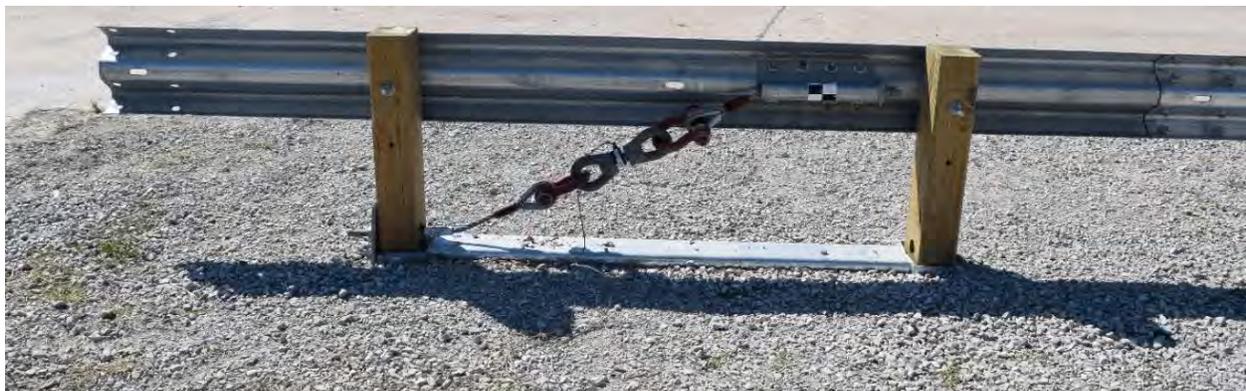
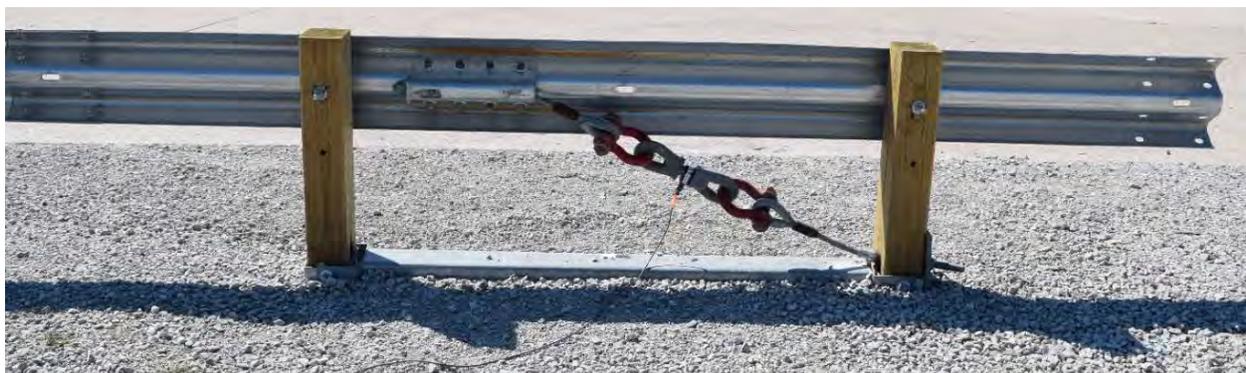
Figure 105. Location of Load Cells: (a) Upstream and (b) Downstream Anchorage Systems

Load cells were installed at the downstream and upstream anchorage systems for test nos. ILT-1 and ILT-2. The load cells were Transducer Techniques model no. TLL-50K with a load range up to 50 kips (222 kN). During testing, output voltage signals were sent from the transducers to a National Instruments PCI-6071E data acquisition board, acquired with LabView software, and stored on a personal computer at a sample rate of 10,000 Hz. The positioning and set up of the transducers are shown in Figure 105.

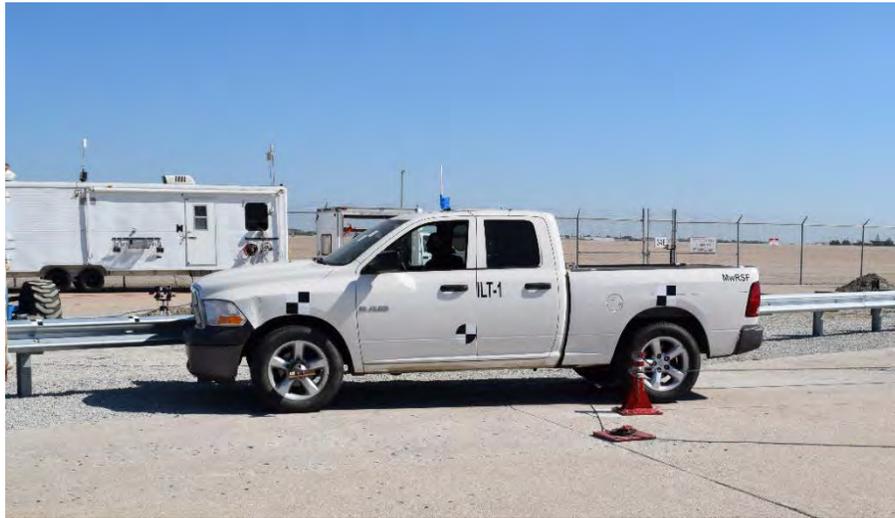
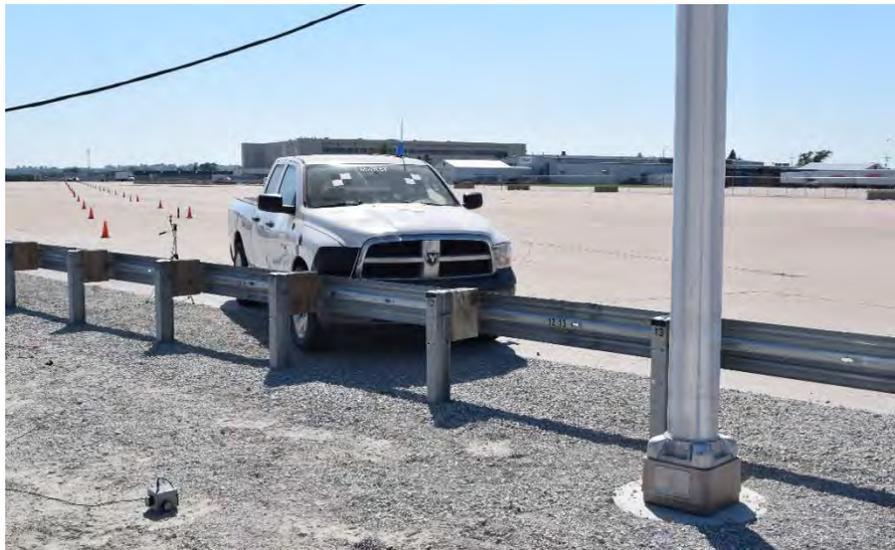
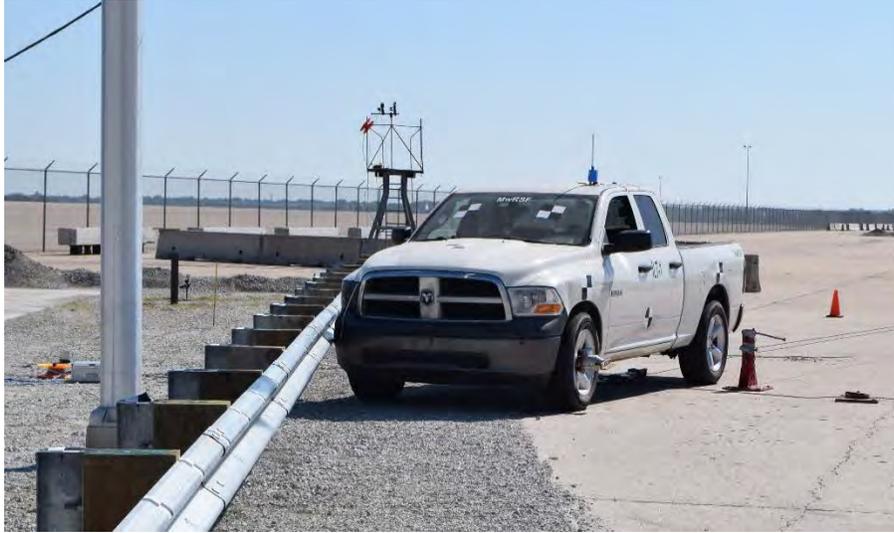
Figure 108. Impact Location, Test No. ILT-1

The 5,000-lb (2,268-kg) Dodge Ram pickup truck impacted the combination MGS with luminaire pole at a speed of 62.6 mph (100.7 km/h) and at an angle of 25.2 degrees. Initial vehicle impact was to occur 4 in. (102 mm) downstream from post no. 11, as shown in Figure 108. As detailed in Chapter 4, the impact point was selected through LS-DYNA analysis to maximize the MGS deflection, the longitudinal ORA, and the potential for vehicle snag. The actual impact point was 3 in. (76 mm) downstream from post no. 11. A sequential description of the impact events is contained in Table 16. A summary of the test results and sequential photographs are shown in Figure 109. Additional sequential photographs are shown in Figures 110 through 111.

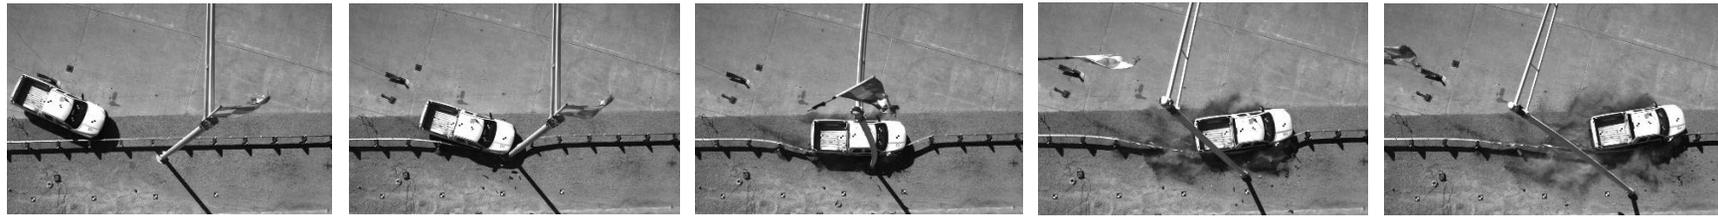
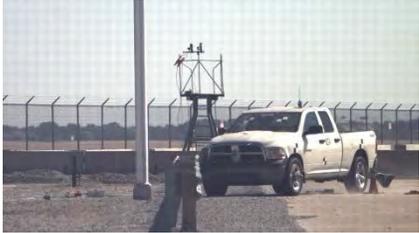
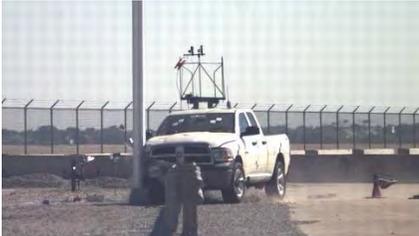
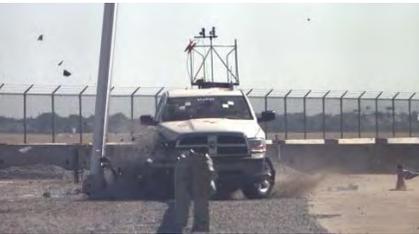
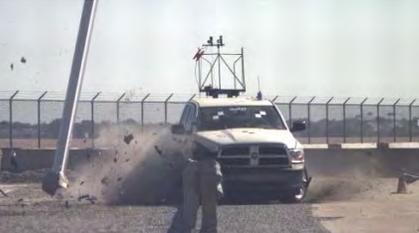
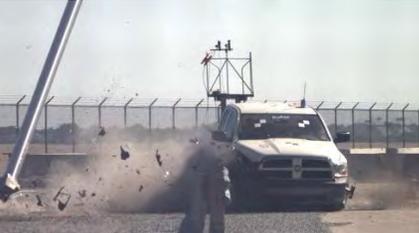
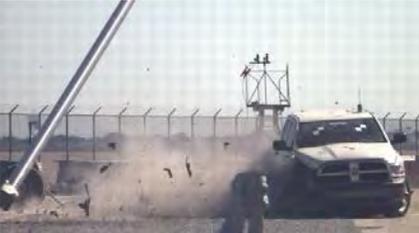
Figure 109. Summary of Test Results and Sequential Photographs, Test No. ILT-1

- Test Agency MwRSF
- Test Number ILT-1
- Date 9/23/16
- MASH Test Designation No. 3-11
- Test Article MGS Offset from Illinois Tollway's Breakaway Light Pole

- Total Length 175 ft (53.3 m)
- Key Component – MGS Rail
 - Thickness 12 gauge (2.66 mm)
 - Top Mounting Height 31 in. (787 mm)
- Key Component – Steel Posts

Evaluation Criteria		Transducer		MASH Limit
		SLICE-1	SLICE-2 (Primary)	
OIV ft/s (m/s)	Longitudinal	-19.4 (-5.9)	-15.3 (-4.7)	± 40 (12.2)
	Lateral	-14.8 (-4.5)	-14.1 (-4.3)	± 40 (12.2)
ORA g's	Longitudinal	-6.2	-14.7	± 20.49
	Lateral	-7.1	-7.8	± 20.49
MAX ANGULAR DISP. deg.	Roll	5.2	-3.0	± 75
	Pitch	-4.9	-5.4	± 75
	Yaw	-33.5	-33.6	Not required
THIV – ft/s (m/s)		19.9 (6.0)	20 (6.1)	Not required
PHD – g's		16.0	16.4	Not required
ASI		0.675	0.714	Not required

Upon impact, the right-front bumper contacted the rail at post no. 11. At 0.160 seconds, the right-front fender struck the pole and began to crush inward. At 0.170, the right-front tire snagged on post no. 13, while the pickup truck was at an angle of 17.3 degrees relative to the MGS. Then, the light pole base fractured, disengaged, and began to fall toward the ground. At 0.320 seconds, the vehicle became parallel to the system, and at 0.860 seconds, the vehicle exited the system. At 1.414 seconds, the pole came to rest on top of the guardrail between post nos. 14 and 15. The vehicle came to rest 83 ft – 6 in. (25.5 m) downstream from impact and 6 ft – 6 in.

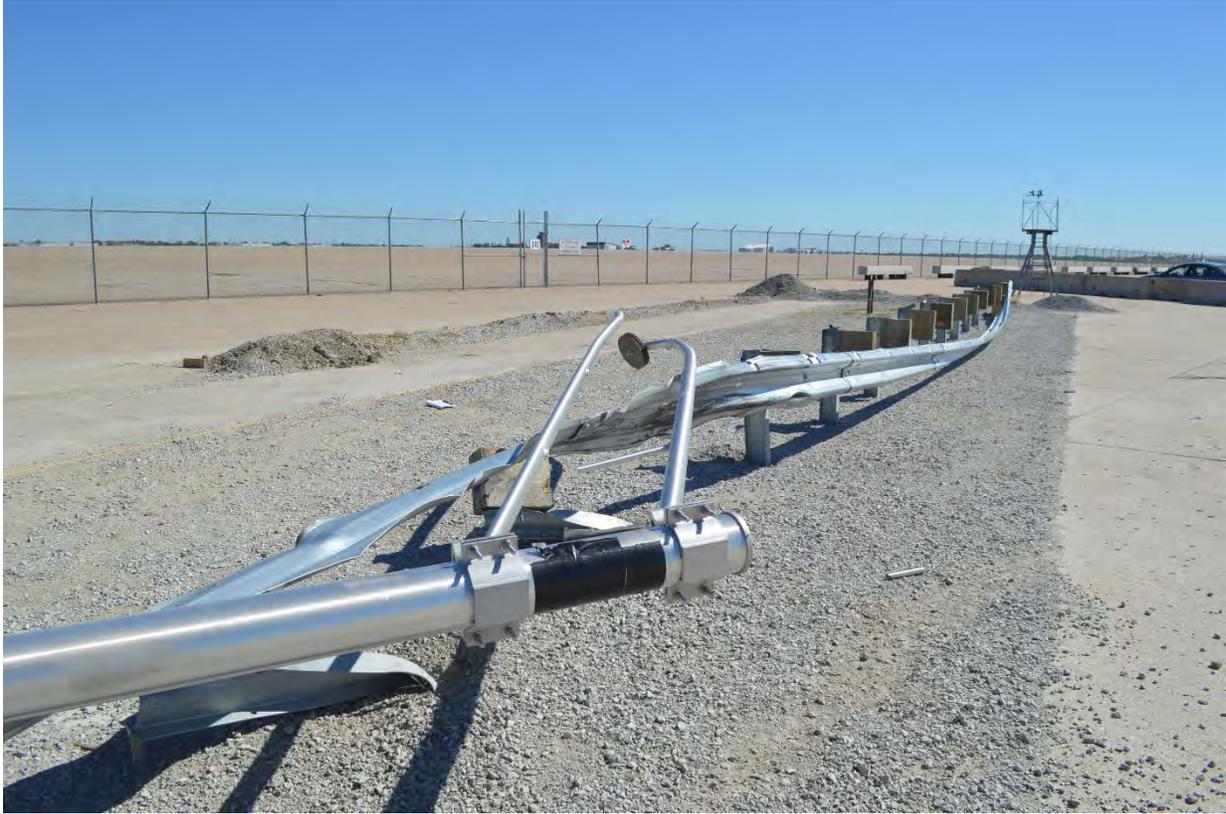
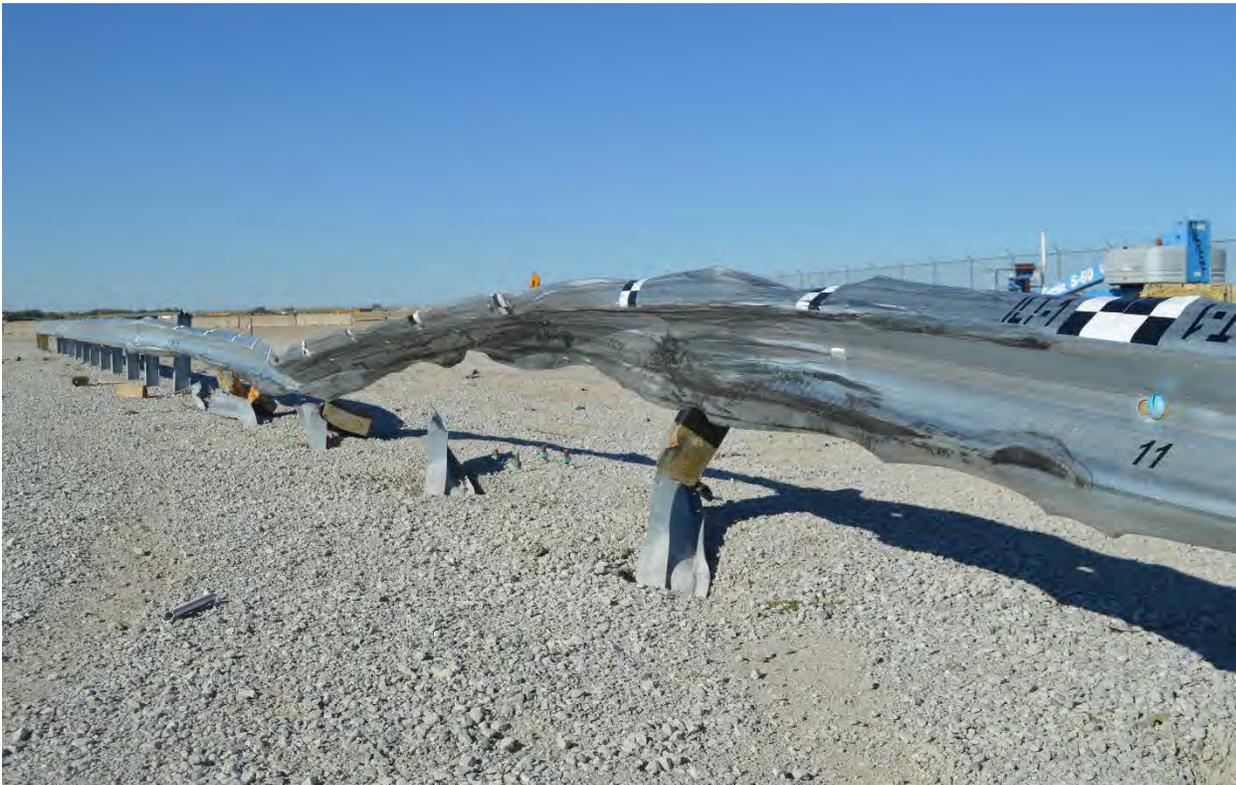
Figure 113. Midwest Guardrail System Damage, Test No. ILT-1

The maximum lateral permanent set rail deflection was 22.5 in. (572 mm) at midspan between post nos. 14 and 15, as measured in the field. The maximum lateral dynamic rail and post deflections were 44.1 in. (1,120 mm) at the midspan between post nos. 14 and 15, and 16 in. (406 mm) at post no. 13, respectively, as determined from high-speed digital video analysis. The working width of the system was 47.3 in. (1,201 mm), as measured at the midspan between post nos. 14 and 15. The light pole landed 25.9 ft (7.9 m) behind and 27 1/8 in. (689 mm) in front of the rail face.

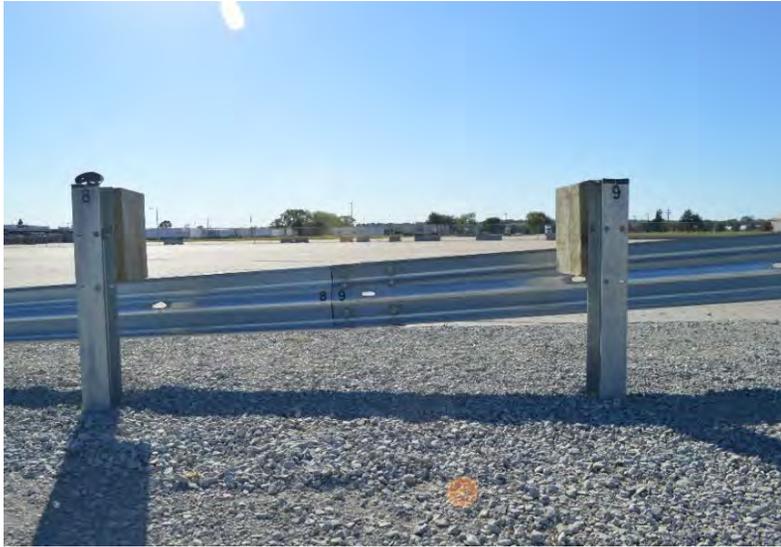
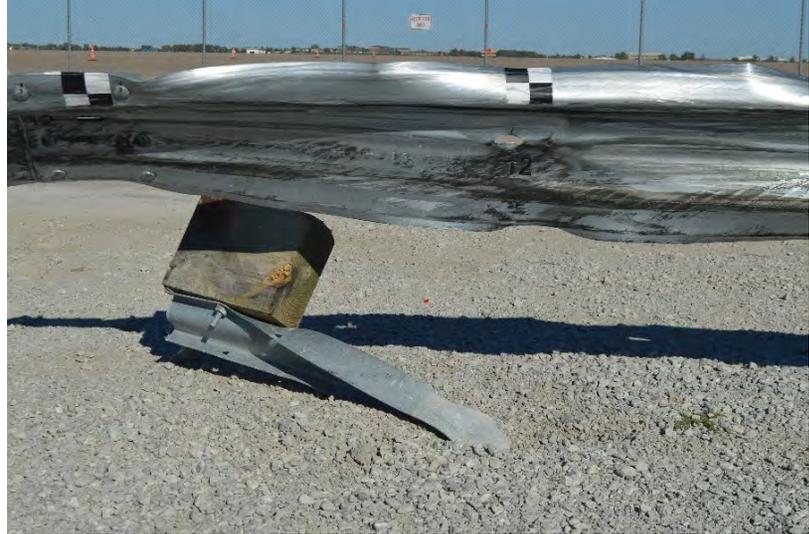
Figure 115. System Damage, Post Nos. 8 through 14, Test No. ILT-1

Damage to the barrier was moderate, as shown in Figures 113 through 118. Barrier damage consisted of deformed guardrail posts, disengaged wooden blockouts, contact marks on a guardrail section and posts, and deformed W-beam rail. The length of vehicle contact along the MGS was approximately 39 ft – 11 in. (12.2 m), which spanned 3 in. (76 mm) downstream from post no. 11 to 32 in. (813 mm) downstream from post no. 17. The second contact between the vehicle and the rail spanned from 32 in. (813 mm) upstream from post no. 24 to 15½ in. (394 mm) upstream from post no. 25.

Moderate deformation and flattening of the W-beam rail occurred between post nos. 11 and 14. Flattening occurred on the bottom corrugation of the rail from 47½ in. (1.2 m) downstream from post no. 11 to 23 in. (584 mm) upstream of the midspan between post nos. 14 and 15. Kinks were found in the rail at the top corrugation 36 in. (914 mm) downstream from post no. 11 and at the bottom corrugation 4½ in. (114 mm) upstream from post no. 12. The W-beam rail released from post nos. 13 through 16 during the impact and disengaged from post nos. 3 through 11 due to the secondary strike from the pole. All splice locations were measured before and after the test. A maximum splice movement of ¾ in. (19 mm) was recorded at one location in the contact region, which was located between post nos. 12 and 13.

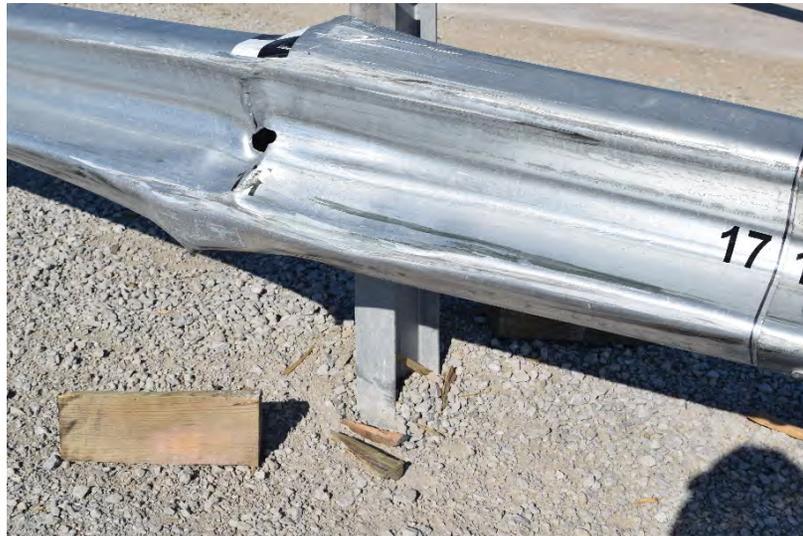
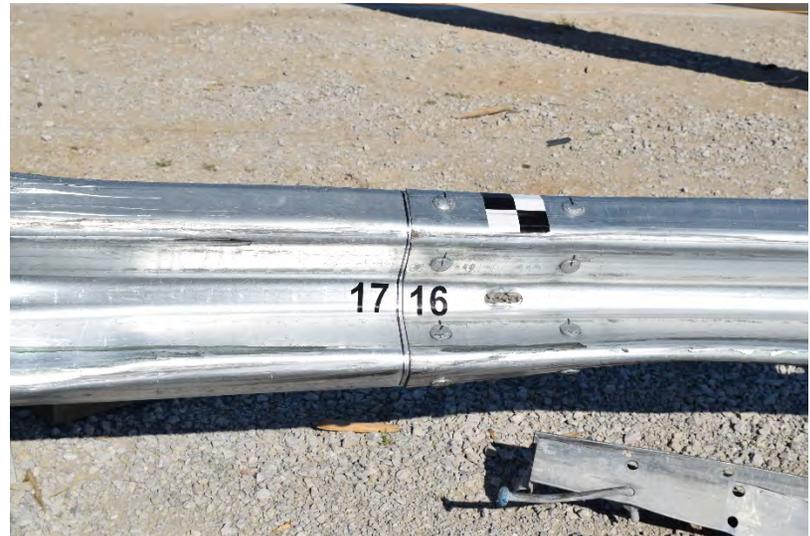
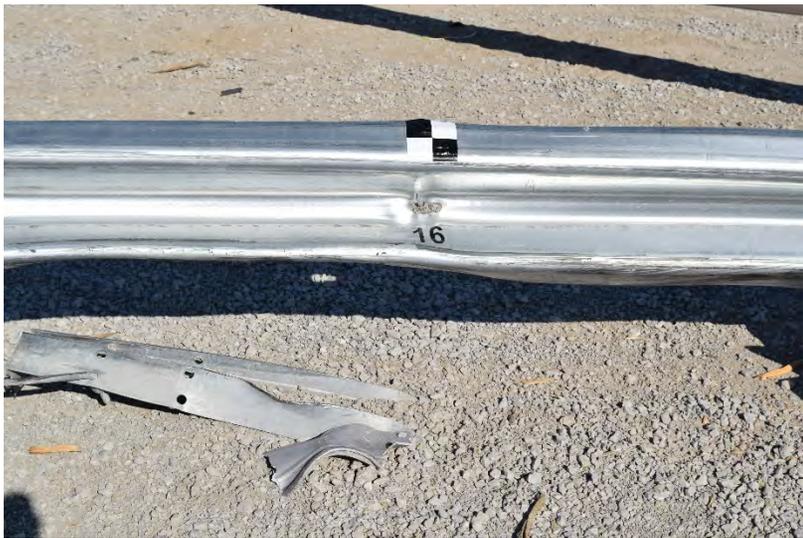
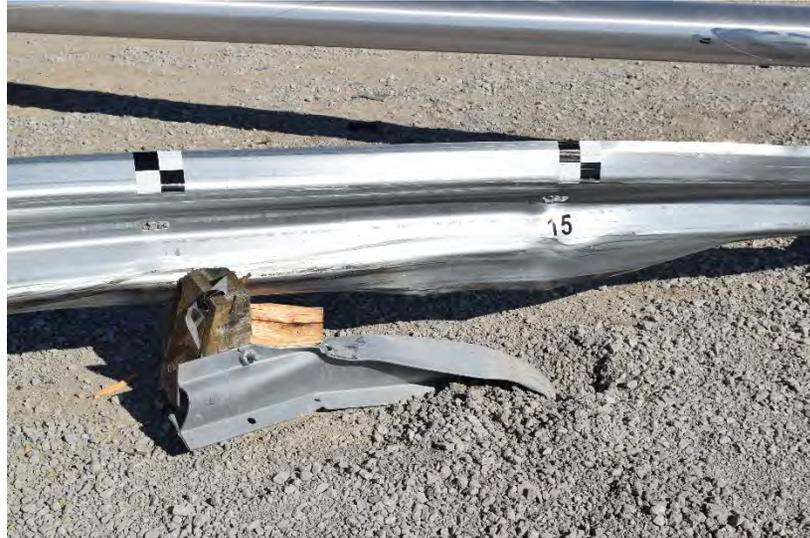
Figure 116. System Damage, Post Nos. 15 through 17 Damage, Test No. ILT-1

Although the post bolts pulled through the rail at the upstream anchor, the cable anchor remained intact between the rail and the bottom of post no. 1, as shown in Figure 118. Blockout no. 13 disengaged away from post no. 13 after the post-to-rail bolt fractured. Post nos. 12 through 16 bent backward and downstream at the ground line. Soil heaves began to form behind the non-traffic side flange of post nos. 12 and 15. The downstream anchorage was undamaged.
