Research Project Number TPF-5(193) Supplement #87

PLACEMENT OF BREAKAWAY LIGHT POLES LOCATED DIRECTLY BEHIND MIDWEST GUARDRAIL SYSTEM (MGS)

MIDWEST ROADSIDE SAFETY FACILITY

MwRSF Research Report No. TRP-03-361-17

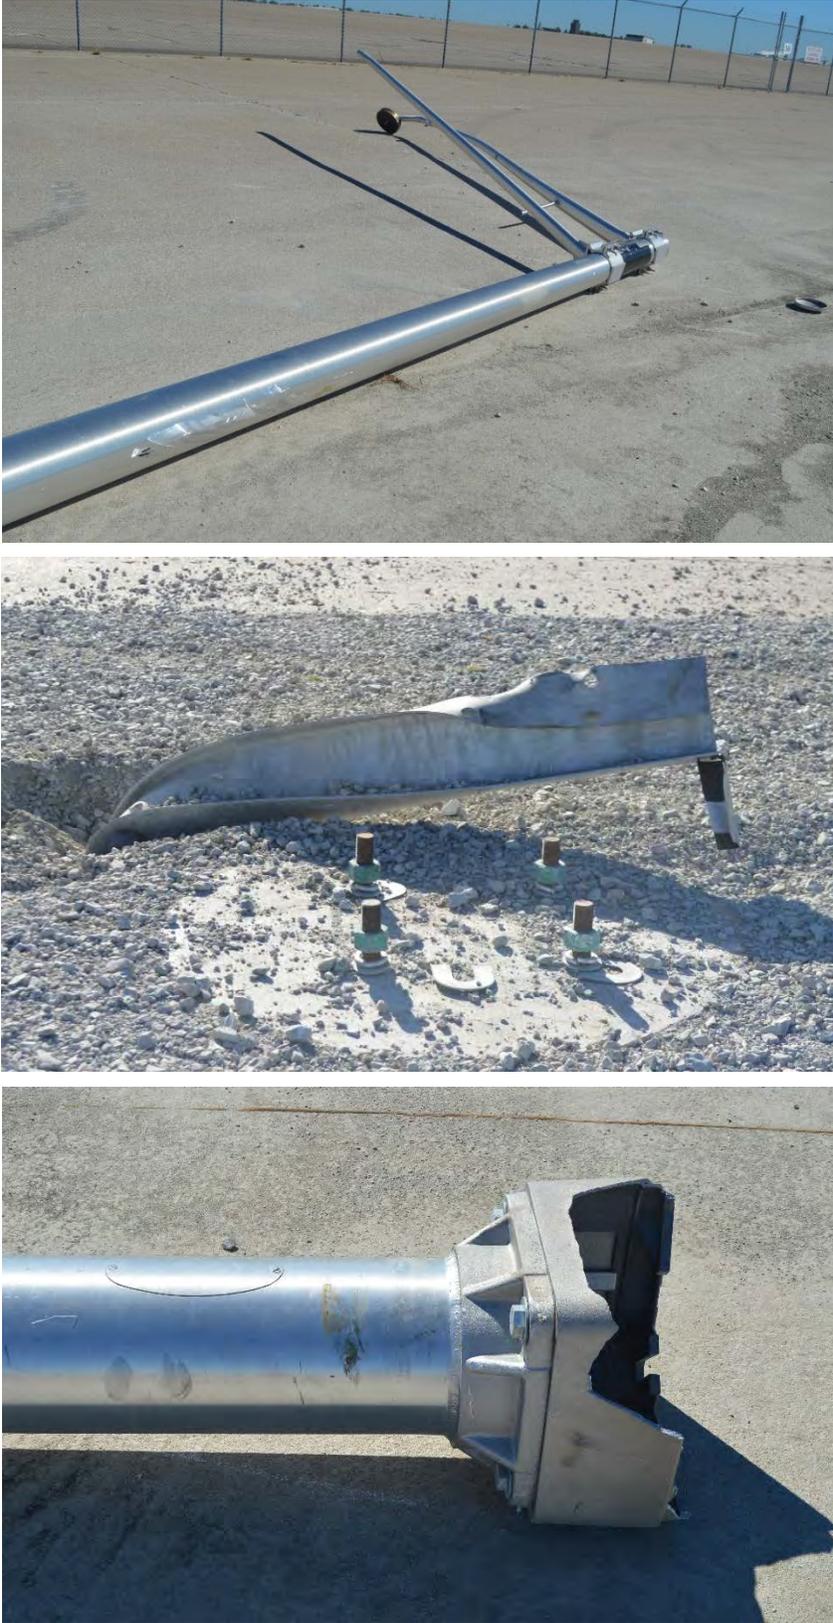
Figure 119. Pole Damage, Test No. ILT-1

In test no. ILT-1, the light pole base fractured, disengaged, thus causing the pole to fall on the guardrail, and then impacted the ground. Pole damage consisted of the base tearing out, detachment of bolt covers, fracture of mast arm braces, and contact marks on the pole and base. A 6-in. tall x 12-in. wide (152-mm tall x 305-mm wide) section on the upstream edge of the transformer base and a 6-in. tall x 4.5-in. wide (152-mm tall x 114-mm wide) section on the front side of the transformer base fractured, as shown in Figure 119. The foundation bolts were exposed, but not damaged. Contact marks were visible at 6 in. (152 mm) and 24 in. (610 mm) above the base along the front side of the pole, while scrapes were found on the back side of the pole at 31 in. above the base. The pole's mast arm braces fractured while hitting the guardrail. The vertical braces of mast arm fractured from the bottom member.

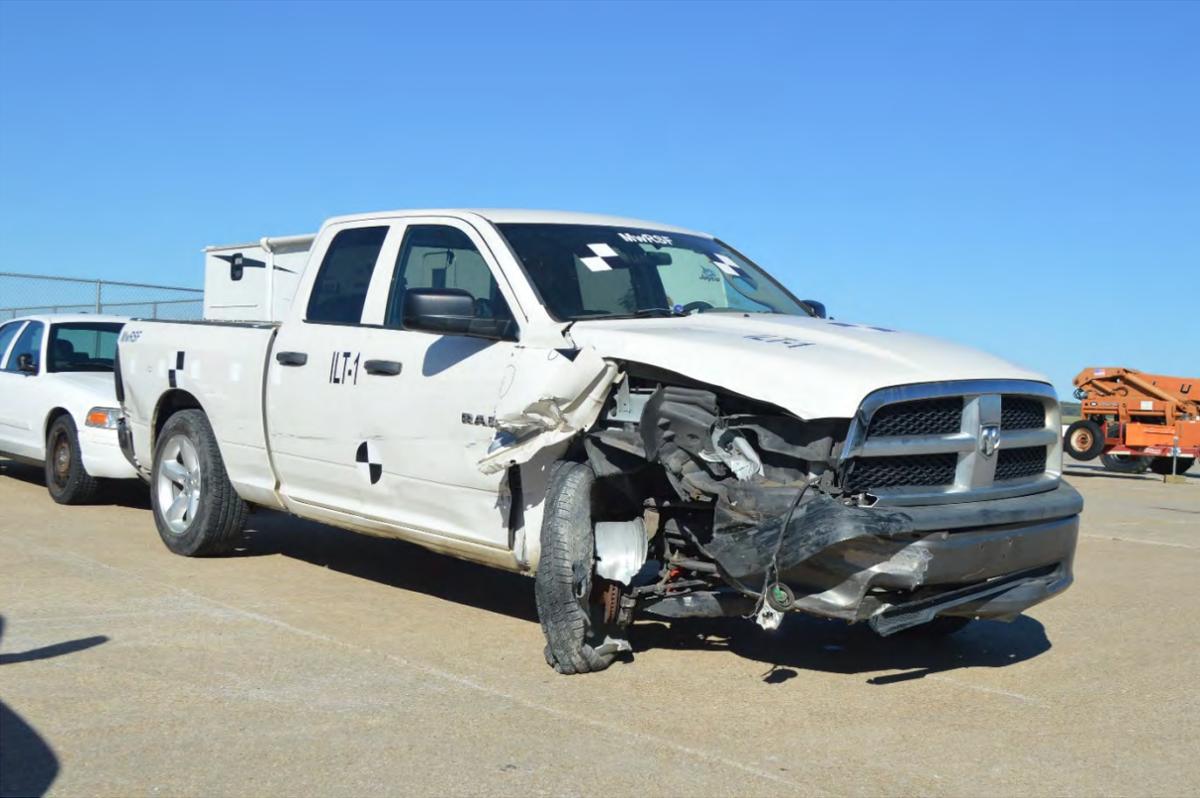
Figure 120. Vehicle Damage, Test No. ILT-1

The majority of vehicle damage was concentrated on the right-front corner and right side of the vehicle where impact occurred. A 9/16-in. (14-mm) gap formed between the hood and right fender. The right-front corner of the bumper was crushed inward approximately 8 in. (203 mm). The right fender was crushed backward to the door panel and was dented and torn behind the right-front wheel. The right-front door had a 5-in. x 2-in. x 1/4-in. (127-mm x 51-mm x 6-mm) dent approximately 8 in. (203 mm) above the bottom. The right headlight fractured and crushed backward. The left taillight cracked. The right-front wheel assembly deformed and crushed inward toward the engine compartment. The right-front tire was deflated, and it had a 1 1/2-in. (38-mm) tear in its sidewall. The right-front rim was fractured, and a 9-in. x 7-in. (229-mm x 178-mm) section disengaged. Gouges and dents were found on the right-front door and the right-front corner of the hood. A 3-in. wide x 1-in. deep x 10-in. long (76-mm x 25-mm x 254-mm) gouge was found on the right-rear bumper. The airbags did not deploy during the impact. The overall undercarriage damage included some scraping on the driver-side front knuckle assembly, a tear above the lower control arm on the frame, and scraping on the transmission cross member end on the passenger side.

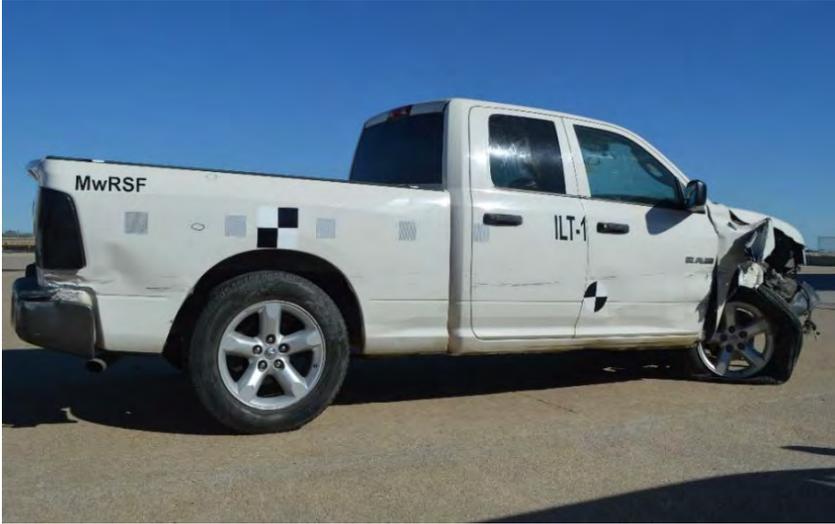
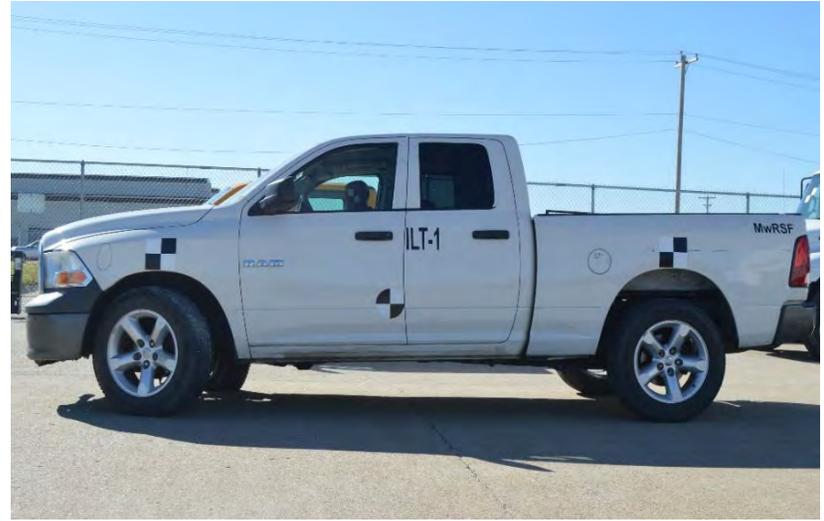
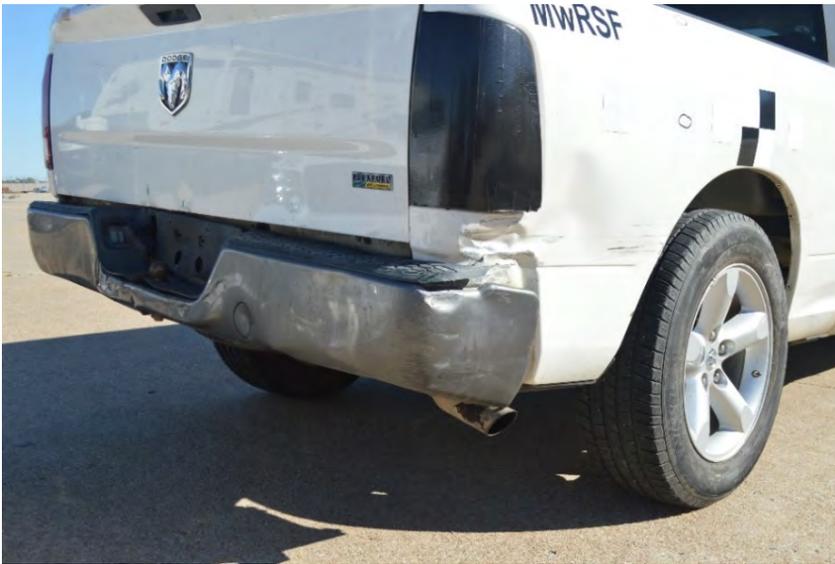
Figure 121. Vehicle Damage, Test No. ILT-1

The damage to the vehicle was moderate, as shown in Figures 120 and 121. The maximum occupant compartment deformations are listed in Table 17 along with the deformation limits established in MASH for various areas of the occupant compartment. None of the established MASH deformation limits were exceeded. Complete occupant compartment and vehicle deformations and the corresponding locations are provided in Appendix H.

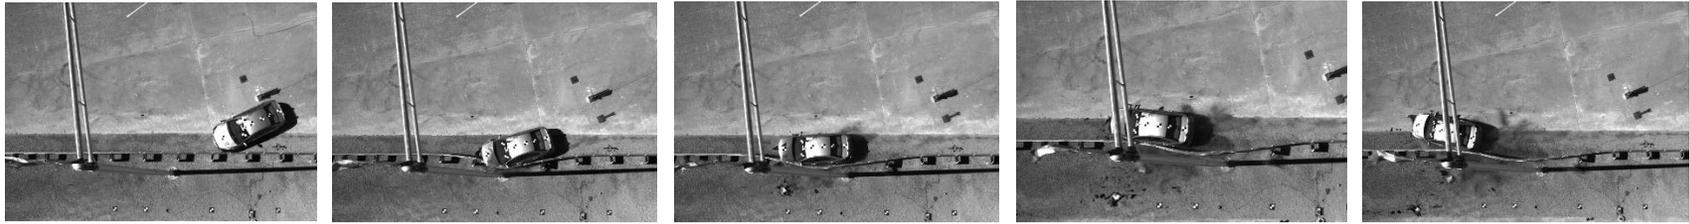
Figure 124. Summary of Test Results and Sequential Photographs, Test No. ILT-2

- Test Agency MwRSF
- Test Number ILT-2
- Date 9/28/16
- MASH Test Designation No. 3-10
- Test Article MGS Offset from Illinois Tollway's Breakaway Light Pole

- Total Length 175 ft (53.3 m)
- Key Component – MGS Rail
 - Thickness 12 gauge (2.66 mm)
 - Top Mounting Height 32 in. (813 mm)
- Key Component – Steel Posts

Evaluation Criteria		Transducer		MASH Limit
		SLICE-1 (Primary)	SLICE-2	
OIV ft/s (m/s)	Longitudinal	-20.0 (-6.1)	-21.0 (-6.4)	± 40 (12.2)
	Lateral	15.4 (4.7)	15.4 (4.7)	± 40 (12.2)
ORA g's	Longitudinal	-10.5	-10.2	± 20.49
	Lateral	10.6	11.0	± 20.49
MAX ANGULAR DISP. deg.	Roll	6.6	7.5	± 75
	Pitch	-3.0	-2.8	± 75
	Yaw	40.6	39.7	Not required
THIV – ft/s (m/s)		24.3 (7.4)	23.9 (7.3)	Not required
PHD – g's		14.3	14.7	Not required
ASI		0.985	0.945	Not required

The 2,420-lb (1,098-kg) Hyundai Accent car impacted the combination MGS with luminaire pole at a speed of 62.7 mph (100.9 km/h) and at an angle of 24.8 degrees. Initial vehicle impact was to occur at midspan between post nos. 11 and 12, as shown in Figure 123, which was selected based on LS-DYNA analysis and previous crash testing. The actual impact point was 1 in. (25 mm) upstream from the targeted impact point (midspan between post nos. 11 and 12). A sequential description of the impact events is contained in Table 20. A summary of the test results and sequential photographs are shown in Figure 124. Additional sequential photographs are shown in Figures 125 and 126.

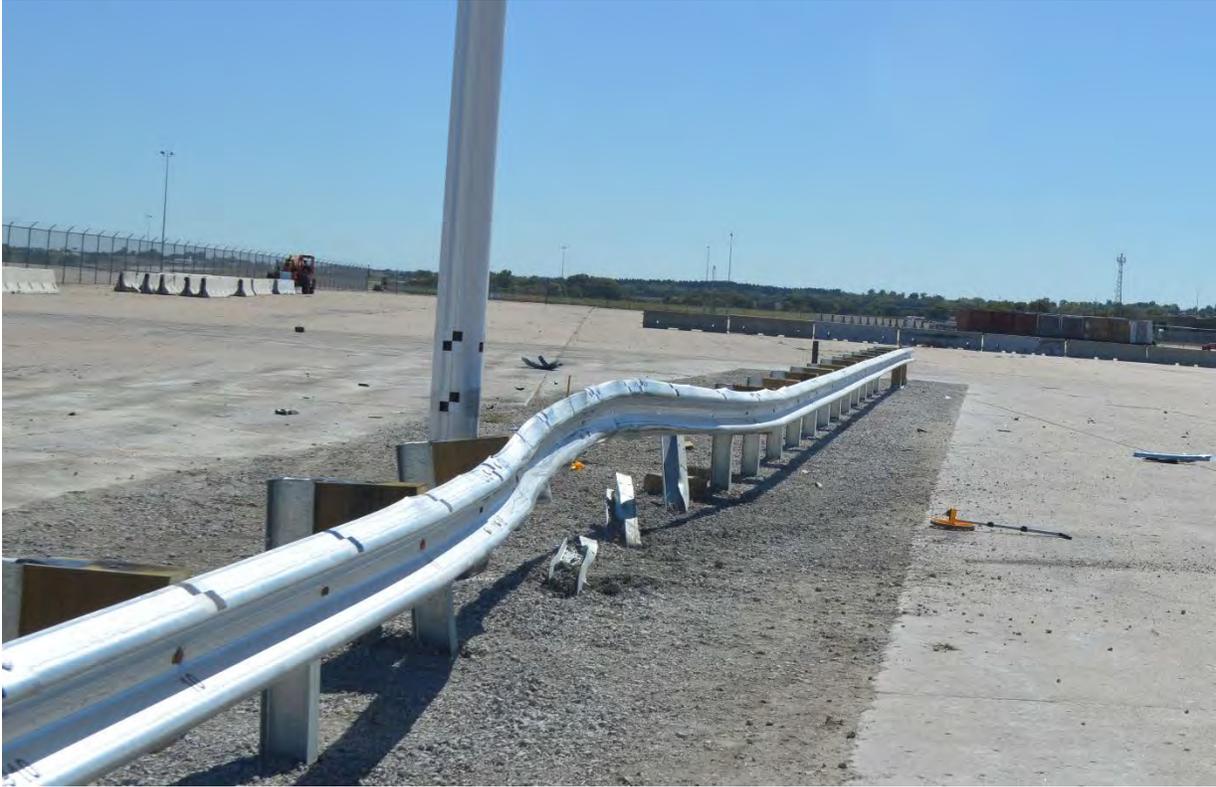
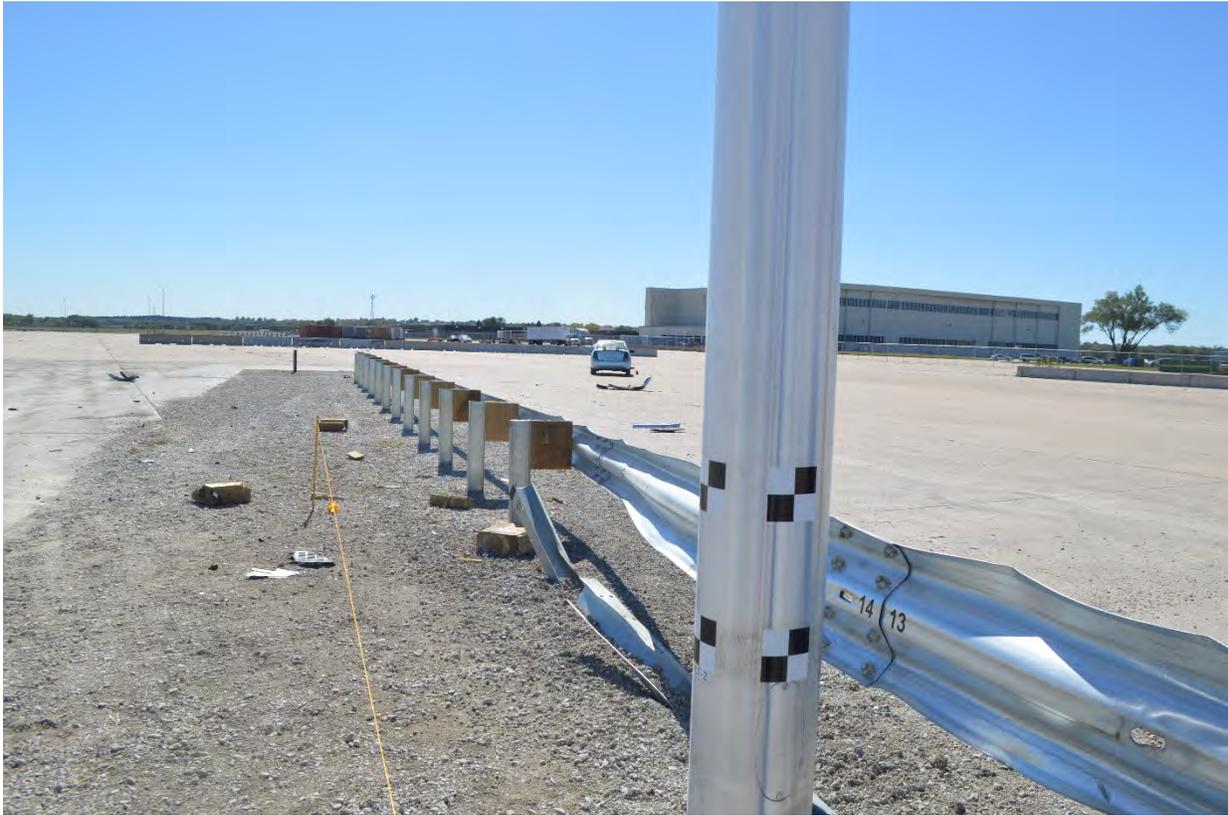
Figure 128. Midwest Guardrail System Damage, Test No. ILT-2

The maximum lateral permanent set rail deflection was 22.5 in. (572 mm) at the midspan between post nos. 13 and 14, as measured in the field. The maximum lateral dynamic rail and post deflections were 29.4 in. (747 mm) at the midspan between post nos. 13 and 14 and 15.1 in. (384 mm) at post no. 14, respectively, as determined from high-speed digital video analysis. The working width of the system was 35.8 in. (909 mm), as measured at the midspan between post nos. 13 and 14.

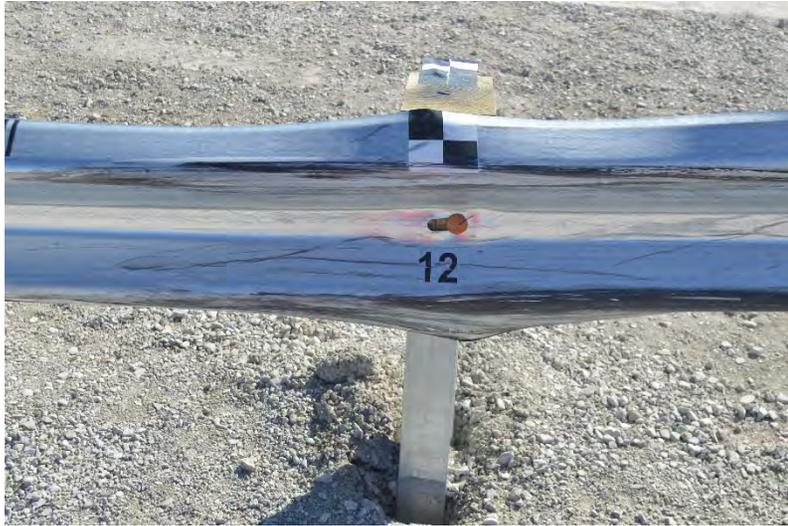
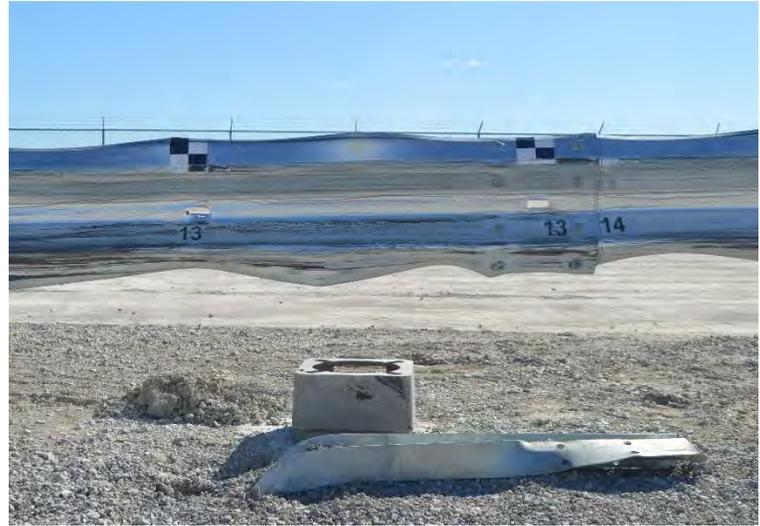
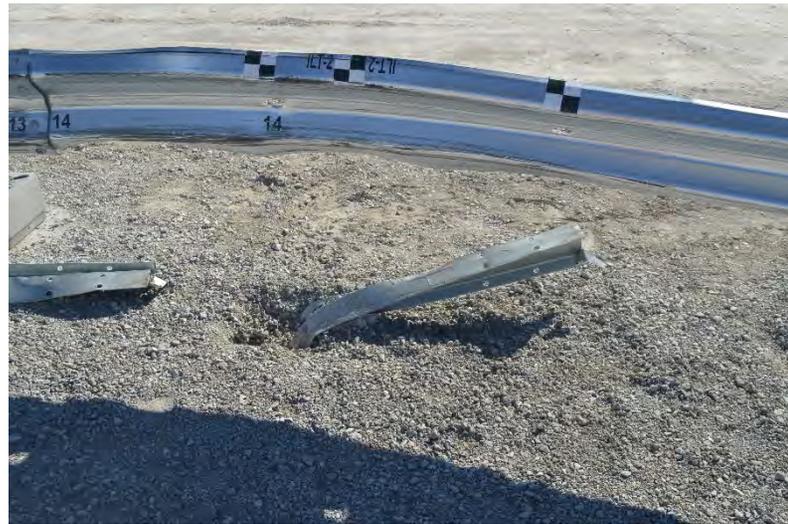
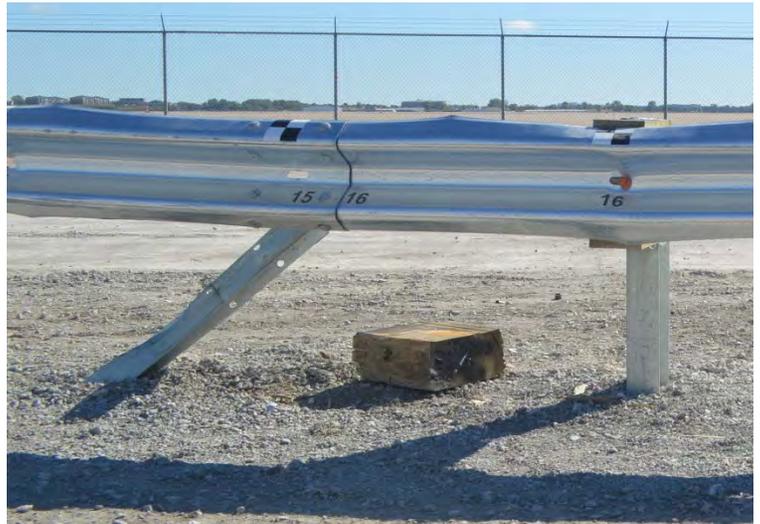
Figure 131. Post Nos. 12 through 15 Damage, Test No. ILT-2

Moderate flattening of the W-beam rail occurred between post nos. 12 and 15. Several kinks were found at the top and bottom corrugations of the rail between post nos. 12 and 16. Tire marks were found at the top and bottom corrugation of the rail beginning from the impact point (1 in. (25 mm) upstream from the midspan between post nos. 11 and 12) up to post no. 16. All splice locations were measured before and after the test. A maximum splice movement of $\frac{3}{4}$ in. (19 mm) was recorded at one location in the contact region, which was located between post nos. 13 and 14.

Post nos. 13 and 14 bent longitudinally downstream at the ground-line. The 20-in. (508-mm) long part of the front flange of post no. 13 twisted. The front upstream flange of post nos. 14 and 15 bent inward toward the web. Post no. 15 partially rotated backward and downstream. Post nos. 13, 14, and 15 disengaged away from the rail. The blockout bolt hole at post no. 16 deformed, but it did not tear. Vertical cracks were found in the blockouts of post nos. 1 through 8, 17 and 18. A $4\frac{1}{4}$ -in. (108-mm) and a $1\frac{1}{4}$ -in. (32 mm) soil gap was found on the front and back sides of post no. 12, respectively. The upstream and downstream anchors were undamaged.

Damage to the barrier was moderate, as shown in Figures 128 through 131. Barrier damage consisted of deformed guardrail posts, disengaged wooden blockouts, contact marks on a guardrail section and posts, and deformed W-beam rail. The length of vehicle contact along the MGS was approximately 27 ft – 11 in. (8.5 m), which spanned from 1 in. (25 mm) upstream from the midspan between post nos. 11 and 12 to 4 in. (102 mm) upstream of post no. 16.

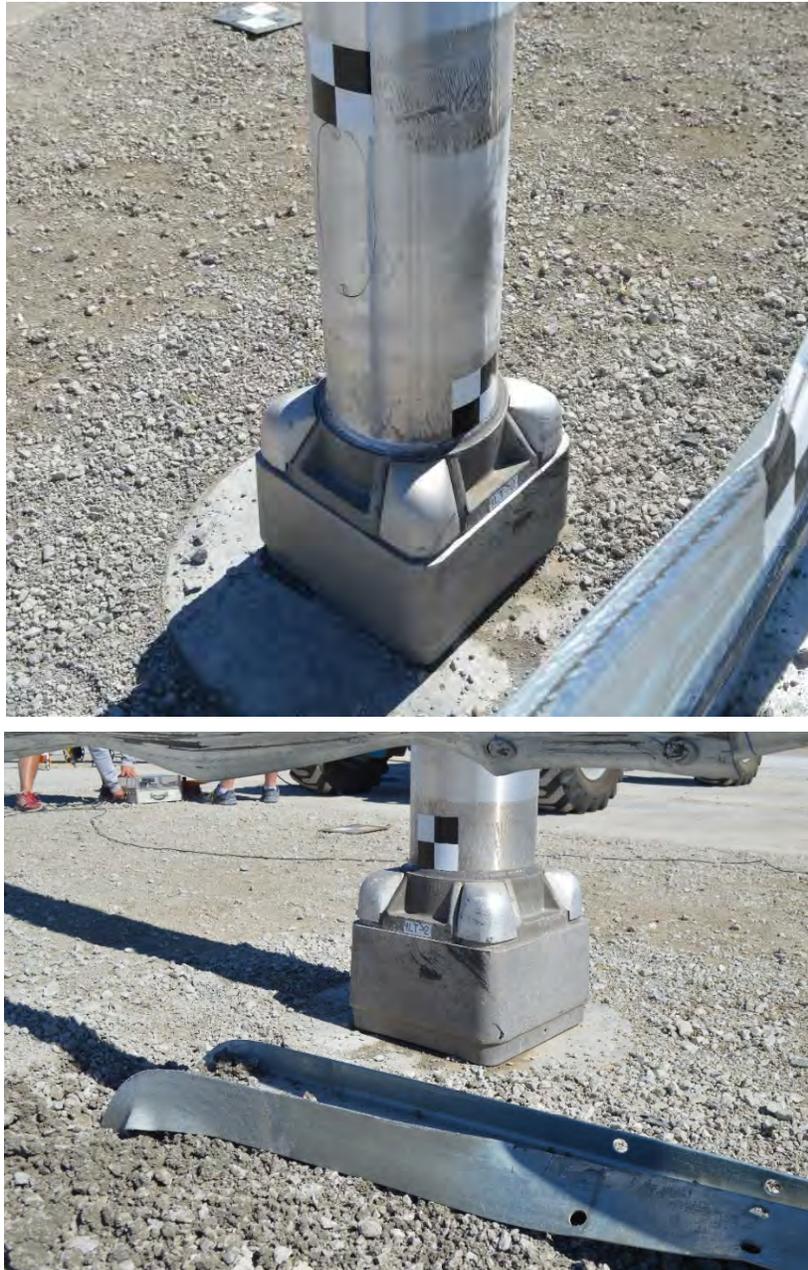
Figure 132. Pole Contact Marks, Test No. ILT-2

In test no. ILT-2, the left-front wheel barely grazed the base of the pole. Thus, the pole did not fracture. Contact marks were visible at the front side of the base, as shown in Figure 132.

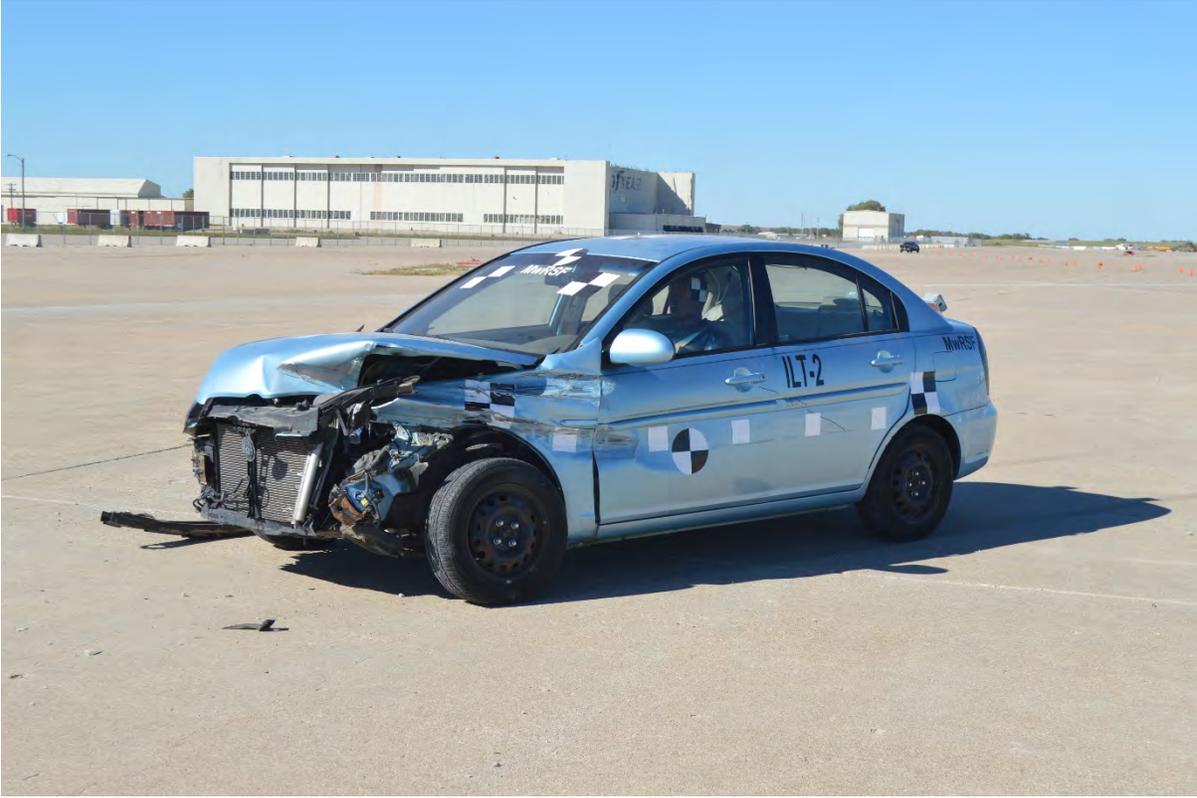
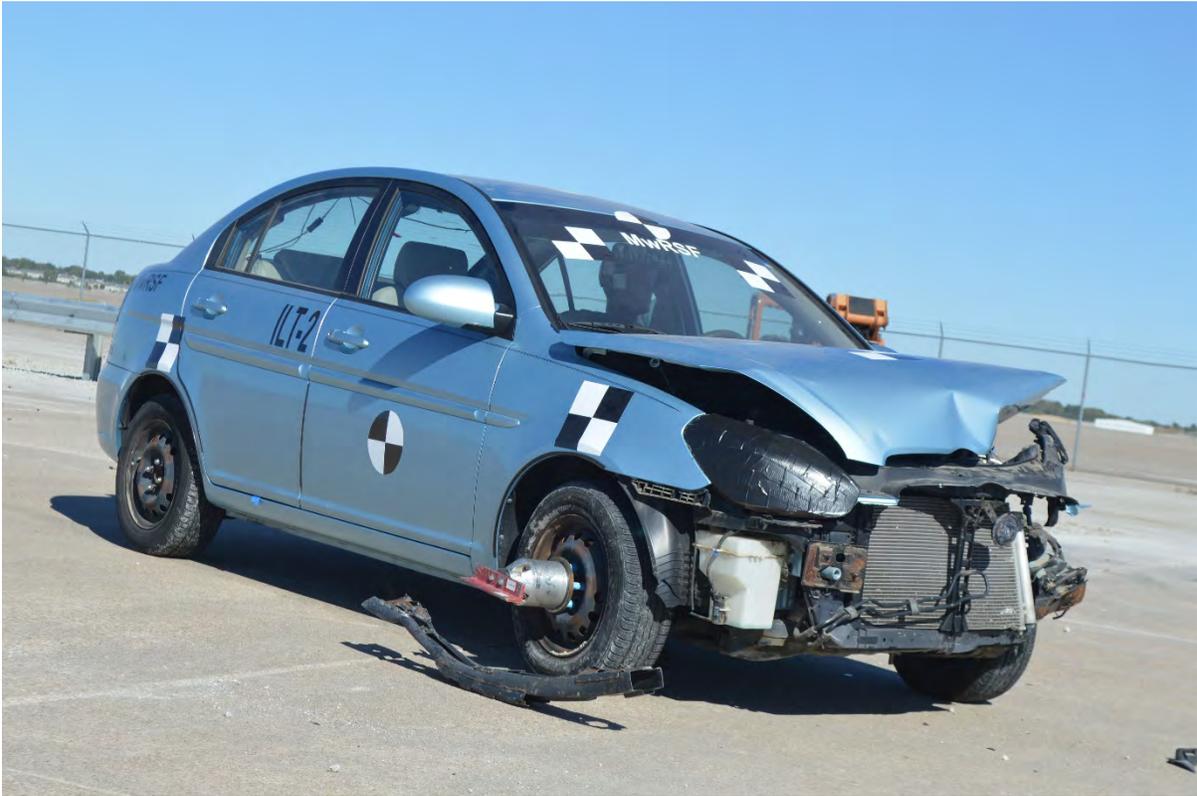
Figure 133. Vehicle Damage, Test No. ILT-2

The overall undercarriage damage of the vehicle included a scrape behind the engine cross member and a 3 in. (76 mm) of crush on the driver-side frame horn. The radiator cross member bent upward on the driver side for 2 in. (51 mm).

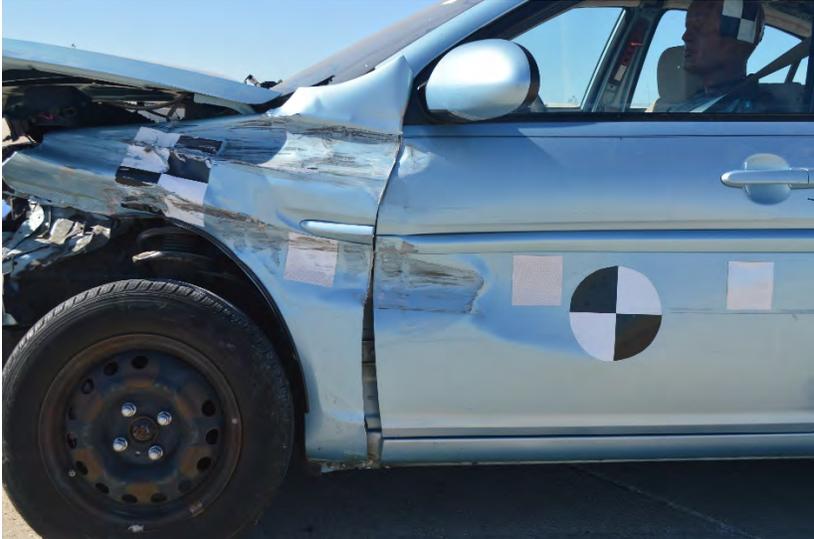
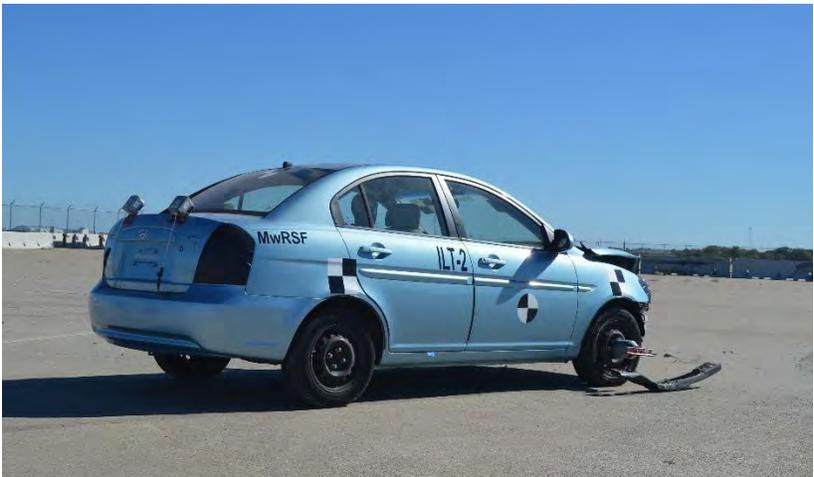
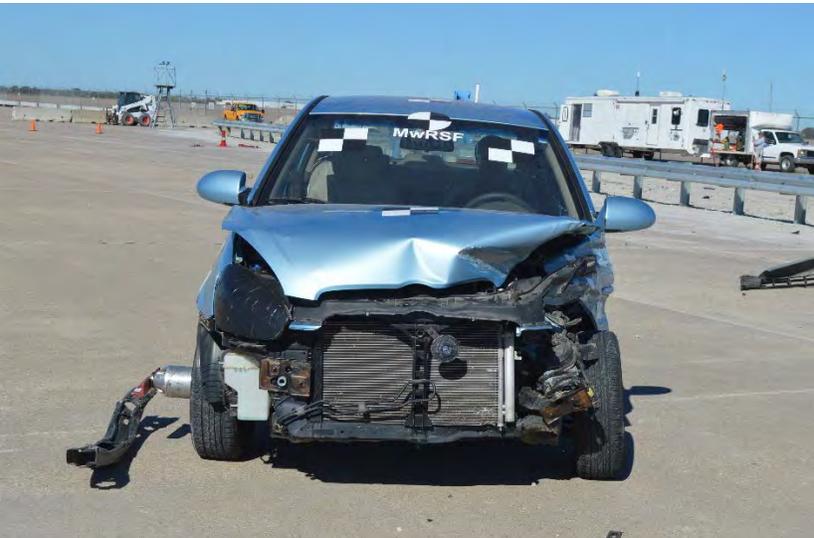
Figure 134. Vehicle Damage, Test No. ILT-2

The vehicle damage was mostly concentrated on the left-front corner, where impact occurred. The left side of the hood buckled upward and crushed backward. The left fender crushed inward approximately 14 in. (356 mm) toward the engine compartment. Scrapes were found along the left fender 18 in. and 26 in. (457 mm and 660 mm) from the bottom of the fender. A 5-in. (127-mm) gap formed between the hood and right fender. The front bumper and bumper cover detached. The left headlight fractured, crushed, and remained attached. A 5-in. wide x ½-in. deep x 8-in. long (127-mm wide x 13-mm deep x 203-mm long) dent and scratches occurred in the left-front door. The radiator bent and dented. The front wheel assembly remained undamaged. The lower left section of the windshield had a crack 11 in. (279 mm) inward and 26 in. (660 mm) upward, as shown in Figure 135. The left fender and the left-front door overlapped ½ in. (13 mm).

The damage to the vehicle was moderate, as shown in Figures 133 through 135. The maximum occupant compartment deformations are listed in Table 21 along with the deformation limits established in MASH for various areas of the occupant compartment. None of the established MASH deformation limits were violated. Complete occupant compartment and vehicle deformations and the corresponding locations are provided in Appendix H.

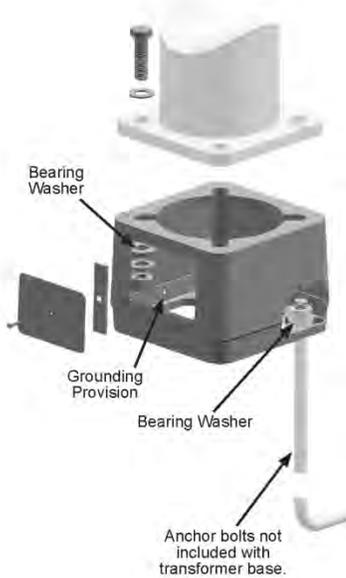
Hardware - Connecting bolts, flat washers, bearing washers and hex nuts are provided per base assembly. All structural fasteners are galvanized high strength carbon steel. All non-structural fasteners are galvanized or zinc-plated carbon steel or stainless steel.

TOP PLATE					BOTTOM PLATE					HEIGHT (IN)	QTY OF ACCESS DOORS	MODEL NUMBER
BOLT CIRCLE			SQUARE (IN)	THK (IN)	BOLT CIRCLE			SQUARE (IN)	THK (IN)			
DIA (IN)	± (IN)	MAX BOLT DIA (IN)			DIA (IN)	± (IN)	MAX BOLT DIA (IN)					
11.25	0.75	1.25	12.25	0.625	11.38	1.38	1.25	12.72	0.625	9.00	1	CS300
