Move Illinois: The Illinois Tollway Driving the Future

Municipal Annual Storm Water Inspection Report

NPDES Permit No. ILR400494 for Discharges from MS4s

Illinois Tollway NPDES Permit No. ILR400494 Reporting Period: March 2019 to March 2020

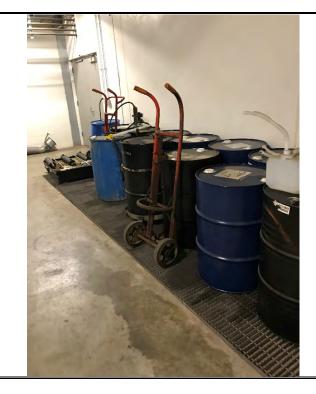
Bulk Oil Storage and Distribution Room.

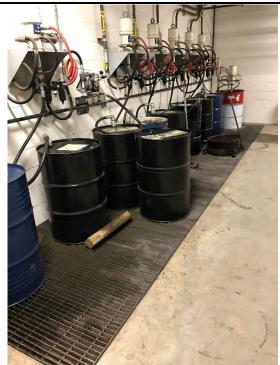
Photo No.	2
Date	5-14-2019
Time	0800
Direction	Northeast
Photo Taken By	RWS

Bulk Oil Storage and Distribution Room.

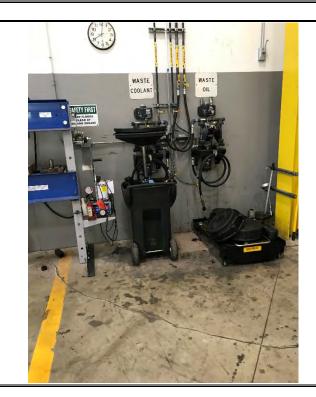
Photo No.	4
Date	5-14-2019
Time	0807
Direction	Southwest
Photo Taken By	RWS

Action Item: Replace "Waste Oil" sign with "Used Oil" per 40 CFR § 279.22. Recommend that "Waste Coolant" sign be replaced with "Used Coolant".

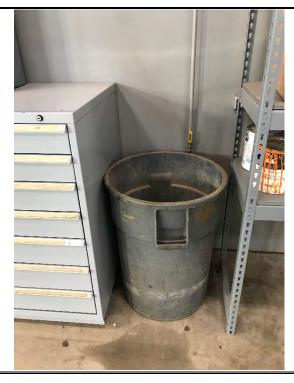
Vehicle Maintenance Shop.

- Label the contents of the clean adsorbent container in the Vehicle Maintenance Area using an adhesive label designed for this purpose (see Photo 4). Deficiency corrected (12-09-2019).

Action Item: Label for the clean adsorbent container using an adhesive label designed for this purpose.

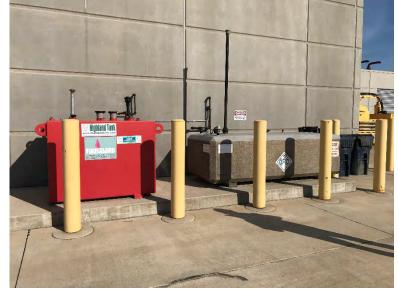
Used Oil and Antifreeze ASTs.

- 4. Replace the faded labels on the Used Oil AST. Ensure legible labels with tank content, storage capacity, hazards, and warnings are provided. Replace the "Waste Oil" label with "Used Oil" per 40 CFR § 279.22. **Deficiency not corrected (See inspection form for details).**

Action Item: Replace faded labels on the Used Oil AST. Replace "Waste Oil" label with "Used Oil" label per 40 CFR § 279.22.

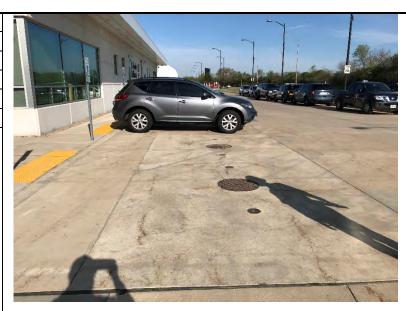
Oil-Water Separator (near Vehicle Maintenance Building).

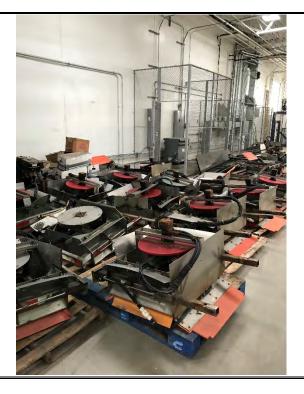
Indoor Salt Spreader Storage Area.

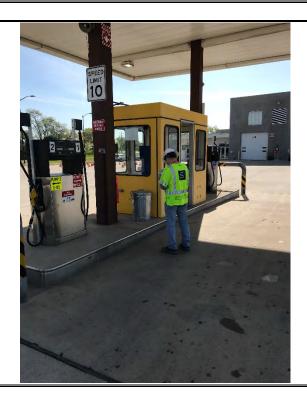
Vehicle Fueling Area.

- Provide a spill kit with adsorbent socks and pads at the Fuel Island to respond to potential larger spills and supplement the granular adsorbent currently provided. Label the existing clean adsorbent container using an adhesive label designed for this purpose. Deficiency corrected (12-09-2019).

Action Item: Label the clean sorbent material container using an adhesive label designed for this purpose. Provide commercial spill kit with sorbent socks and pads for responding to larger spills.

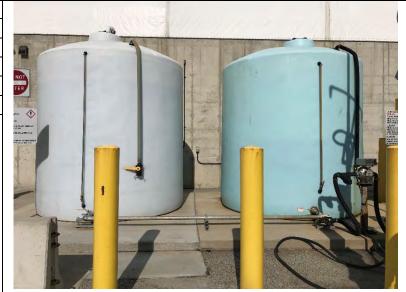
Photo No.	12
Date	5-14-2019
Time	0842
Direction	West
Photo Taken By	RWS

Brine AST and Calcium Chloride AST.

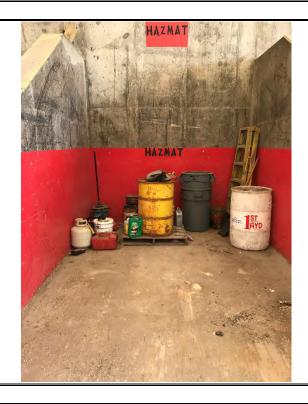
Photo No.	14
Date	5-14-2019
Time	0847
Direction	South
Photo Taken By	RWS

Action Item: Provide closed and sealed lids for all containers. Label all containers with contents and generation date using an adhesive label designed for this purpose.

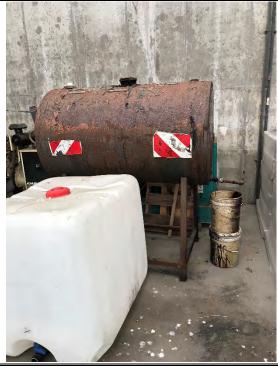
Emulsion AST (inside Salt Dome).

- 6. The Asphalt Emulsion AST is not labeled and is corroded. Label the tank with contents, storage capacity, hazards, and warnings. Consider replacing the tank due to corrosion. **Deficiency corrected (12-09-2019).**

Action Item: Provide labeling for the tank including contents, capacity, hazards, and warnings. Consider replacing the tank due to corrosion.

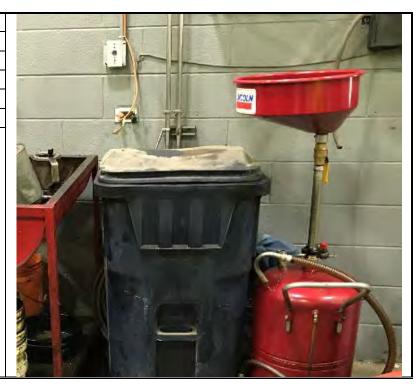
Used Oil Filter Bin

- 8. Label the contents of the Used Oil Filter Bin using an adhesive label designed for this purpose. **Deficiency corrected (12-09-2019).**
- Label all containers in the Hazardous Waste Accumulation Area with contents and generation date using an adhesive label designed for this purpose. Deficiency corrected (12-09-2019).

Action Item: Provide labeling for the Used Oil Filter Bin using an adhesive label designed for this purpose.

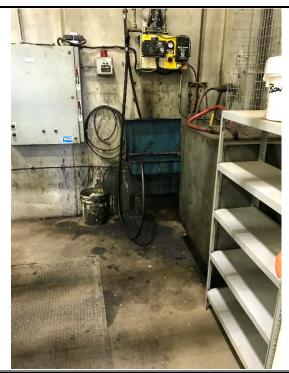
Photo No.	2
Date	5-14-2019
Time	West
Direction	09:55
Photo Taken By	RWS

Used Oil Transfer Area.

- 10. Provide labeling for the Asphalt Emulsion AST including contents, capacity, hazards and warnings. **Deficiency corrected (12-09-2019).**
- 11. Oil stains are located at various locations in the Vehicle Service Area and Used Oil/Antifreeze Transfer Area. Clean the area of the stains using an enzyme or biodegradable cleaner. Use drip pans and adsorbent pads where practical during operations. **Deficiency corrected (12-09-2019).**

Action Item: Clean the area of the stains using an enzyme or biodegradable cleaner. Use drip pans and adsorbent pads where practical.

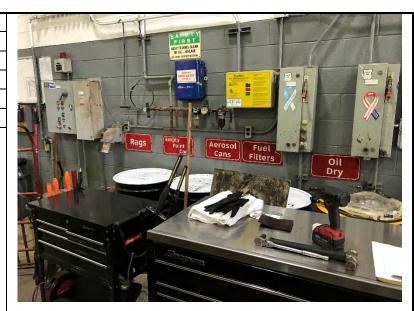
Photo No.	4
Date	5-14-2019
Time	10:03
Direction	West
Photo Taken By	RWS

Action Item: Label all containers with contents and generation date using an adhesive label designed for this purpose.

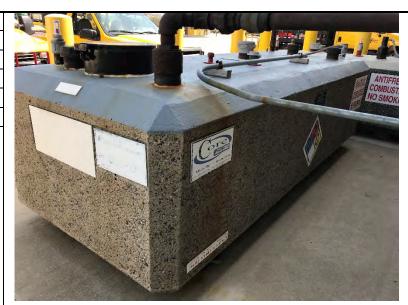
Photo No.	6
Date	5-14-2019
Time	10:17
Direction	West
Photo Taken By	RWS

Action Item: Replace the faded labels on the tank. Ensure that legible labels with tank content, storage capacity, hazards, and warnings are provided. Replace "Waste Oil" label with "Used Oil" label per 40 CFR § 279.22.

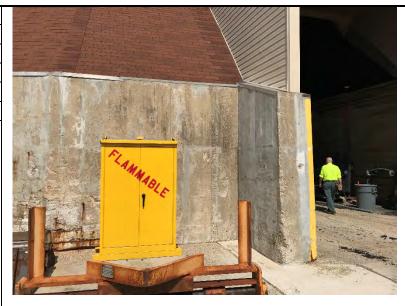
Flammables Storage Cabinet (near Salt Dome).

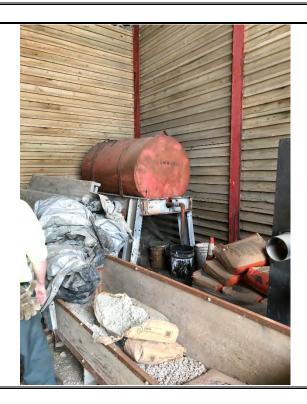
Photo No.	8
Date	5-14-2019
Time	10:20
Direction	West
Photo Taken By	RWS

Emulsion AST (inside Salt Dome.)

Action Item: Provide labeling for the tank including contents, capacity, hazards, and warnings.

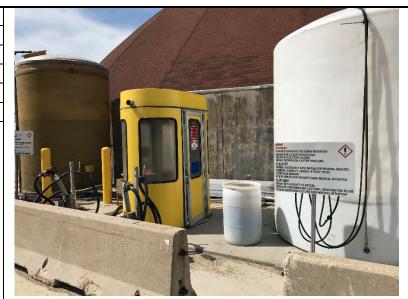
Photo No.	10
Date	5-14-2019
Time	10:27
Direction	Northeast
Photo Taken By	RWS

Action Item: Return contents of 55-gallon polyethylene drum containing chloride/brine solution to storage tank or dispose properly. Repair the small leak that was observed near the distribution valves/fittings.

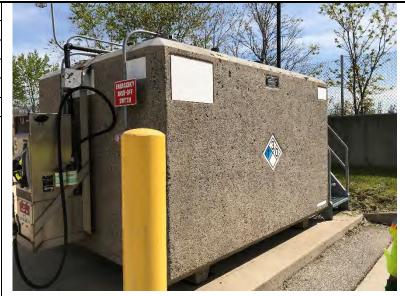
E-85 AST.

- 3. Replace the faded labels on the E-85 Aboveground Storage Tank. Ensure that legible labels with tank content, storage capacity, hazards, and warnings are provided. Provide a spill kit with adsorbent socks and pads at the E-85 AST. **Deficiency corrected (12-09-2019).**

Action Item: Replace the faded labels on the tank. Ensure that legible labels with tank content, storage capacity, hazards, and warnings are provided. Provide a spill kit at the tank location.

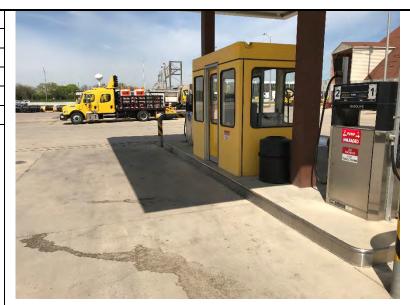
Vehicle Fueling Area.

- 1. Provide signage to identify the contents of dumpsters. **Deficiency corrected (12-09-2019).**
- Provide a spill kit with adsorbent socks and pads at the Fuel Island to respond to larger spills and supplement the granular adsorbent currently provided. Label the existing clean adsorbent material container with an adhesive label designed for this purpose. Deficiency corrected (12-09-2019).

Action Item: Provide label for the clean sorbent material container using an adhesive label designed for this purpose. Provide commercial spill kit with sorbent socks and pads for responding to larger spills.

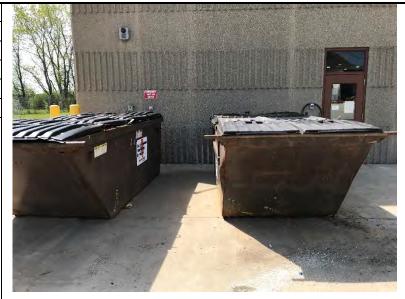
Photo No.	12
Date	5-14-2019
Time	10:32
Direction	South
Photo Taken By	RWS

General Refuse Dumpsters.

Action Item: Provide signage to identify the contents of dumpsters.

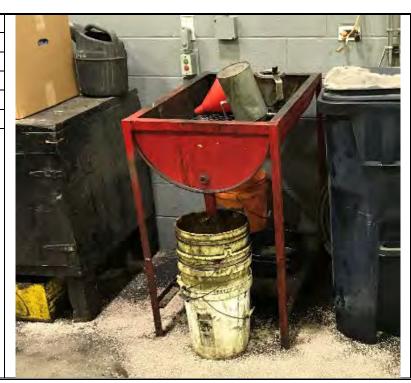
Oil Filter Draining Station.

- 7. Provide a commercial drip pan for use at the Used Oil Filter Draining Station, eliminating use of an open top bucket. Clean areas of spills with adsorbent and an enzyme or biodegradable cleaner. **Deficiency corrected (12-09-2019).**

Action Item: Provide a commercial drip pan to avoid accidental spillage using a 5-gallon open top bucket for this purpose. Clean areas of spills with adsorbent and an enzyme or biodegradable cleaner.

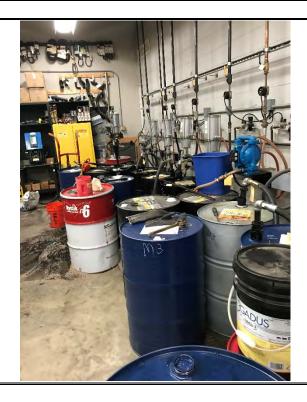
Bulk Oil Storage and Distribution Area.

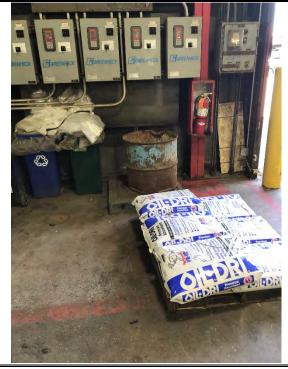
Photo No.	2
Date	5-14-2019
Time	11:22
Direction	North
Photo Taken By	RWS

Oil-Dry Storage Container (inside Maintenance Building).

- 8. Label the clean adsorbent container in the Vehicle Maintenance Area using an adhesive label designed for this purpose. **Deficiency not corrected (See inspection form for details).**

Action Item: Label the clean adsorbent container in the Vehicle Maintenance Area using an adhesive label designed for this purpose.

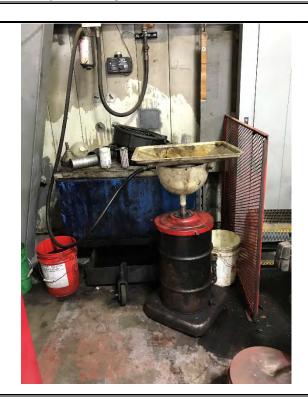
Photo No.	4
Date	5-14-2019
Time	11:28
Direction	Northeast
Photo Taken By	RWS

Action Item: Active oil spill and stains are present in the Vehicle Service Area and the Used Oil Filter Draining Area. Clean the areas with adsorbents and an enzyme or biodegradable cleaner, use and provide drip pans and sorbent pads where practical, and hang hoses to prevent drips.

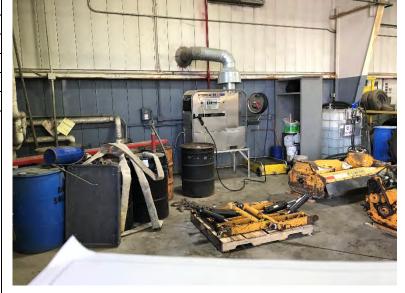
Storage Area in northeast corner of the Maintenance Building.

- 10. Remove and properly dispose of any surplus or out-of-date drummed material from inside the Maintenance Building. **Deficiency corrected (12-09-2019).**

Action Item: Remove and properly dispose of any surplus or out-of-date drummed material.

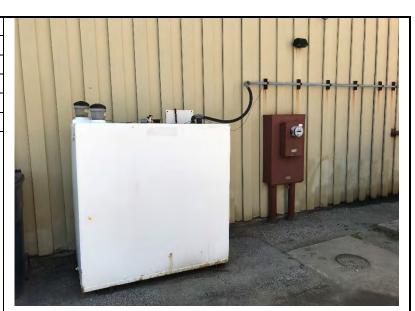
Photo No.	6
Date	5-14-2019
Time	11:35
Direction	East
Photo Taken By	RWS

Action Item: Replace faded labels on the Used Oil Above Ground Storage Tank. Ensure that legible labels with tank content, storage capacity, hazards, and warnings are provided. Replace "Waste Oil" label with "Used Oil" label per 40 CFR § 279.22.

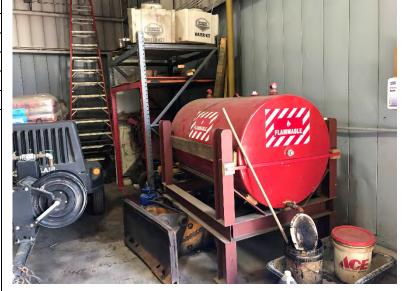
Asphalt Emulsion AST (inside the Storage Building.)

- 9. Provide labeling for the Asphalt Emulsion AST including contents, storage capacity, hazards, and warnings. Verify the use of the existing "Flammable" labeling. **Deficiency not corrected (See inspection form for details).**

Action Item: Provide labeling for the Asphalt Emulsion AST including contents, storage capacity, hazards, and warnings. Verify the use of the existing "Flammable" labeling.

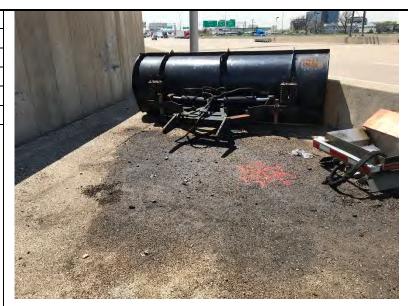
Photo No.	8
Date	5-14-2019
Time	11:45
Direction	Southeast
Photo Taken By	RWS

Action Item: Cap and seal all hydraulic lines and repair leaking equipment. Clean spill areas using adsorbent and an enzyme or biodegradable cleaner.

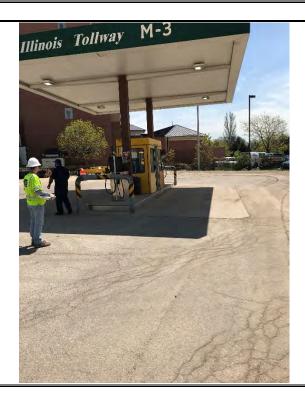
Vehicle Fueling Area.

- 4. Provide a spill kit with adsorbent socks and pads at the Fuel Island to respond to larger spills to supplement the granular adsorbent currently provided. Label the existing clean adsorbent material container with an adhesive label designed for this purpose. **Deficiency** corrected (12-09-2019).

Action Item: Provide a spill kit at the Fuel Island to respond to larger spills and supplement the granular adsorbent currently provided. Label the existing clean adsorbent material container using an adhesive label designed for this purpose.

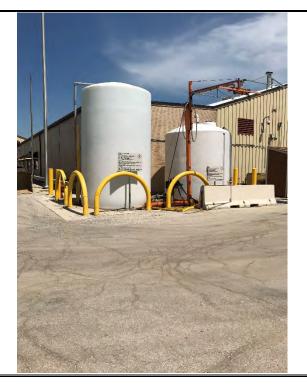
Brine AST and Calcium Chloride AST.

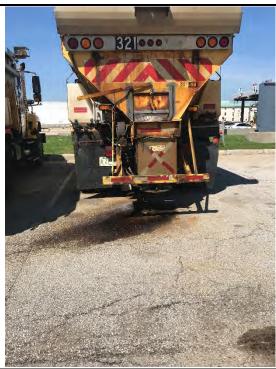
Photo No.	10
Date	
Time	
Direction	West
Photo Taken By	RWS

Truck Parking Area.

- Active equipment hydraulic leaks were observed in the Truck Parking Area. Repair leaking
 equipment and maximize use of drip pans or adsorbent pads where practical. Clean spill
 areas using adsorbent and an enzyme or biodegradable cleaner. **Deficiency corrected**(12-09-2019).

Action Item: Repair leaking equipment and maximize use of drip pans or adsorbent pads where practical. Clean spill areas using adsorbent and an enzyme or biodegradable cleaner.

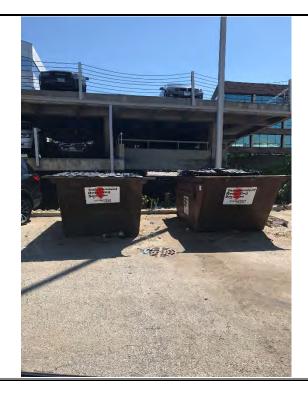
Dumpster Area.

- 2. Provide signage to identify the contents of dumpsters. **Deficiency not corrected (See inspection form for details).**
- 3. Ensure that lids for refuse dumpsters remain closed when not in use. **Deficiency** corrected (12-09-2019).

Action Item: Provide signage to identify the contents of dumpsters.

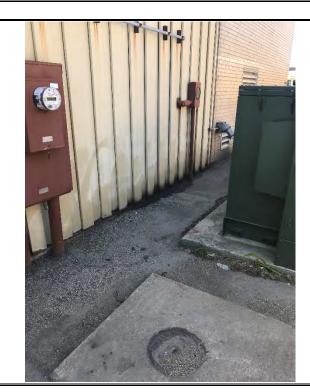
Oil stains are present on the pavement outside the maintenance facility, directly behind the Used Oil Filter Draining Station.

- Active oil spill and stains are present in the Vehicle Service Area and Used Oil Transfer Area. Clean the areas with adsorbents and an enzyme or biodegradable cleaner, use and provide drip pans and adsorbent pads where practical, and hang hoses to prevent drips.
 Deficiency corrected (12-09-2019).

Action Item: Clean oil stained areas with an enzyme or biodegradable cleaner.

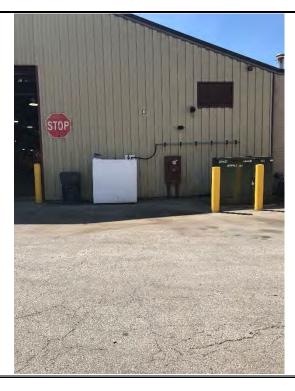
Photo No.	14
Date	
Time	
Direction	
Photo Taken By	RWS

Used Oil Filter Bin Area.

Action Item: Label the contents of the Used Oil Filter Bin using an adhesive label designed for this purpose

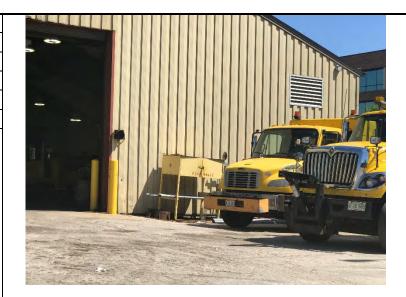
Flammables Storage Cabinet.

Action Item: Relocate the cabinet to a location where a leak or spill will not enter a storm drain, preferably indoors.

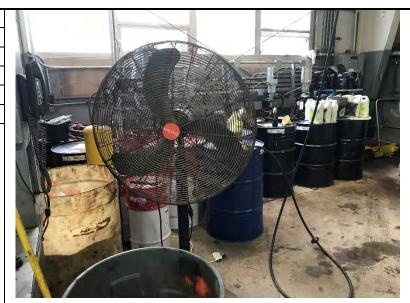
Bulk Oil Storage and Distribution Area.

Action Item: Label the clean adsorbent container in the Vehicle Maintenance Area using an adhesive label designed for this purpose.

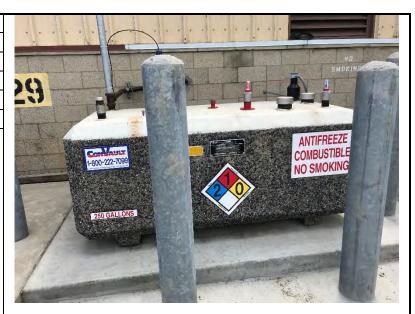
Photo No.	4
Date	5-14-2019
Time	13:16
Direction	west
Photo Taken By	RWS

Action Item: Replace faded labels on the Used Oil AST. Ensure that legible labels with tank content, storage capacity, hazards, and warnings are provided. Replace "Waste Oil" label with "Used Oil" label per 40 CFR § 279.22.

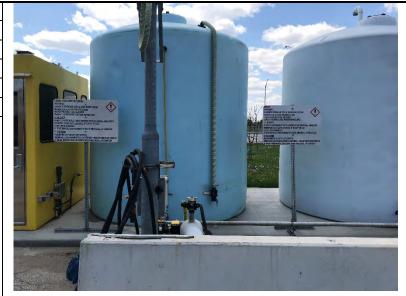
Salt Brine and Calcium Chloride ASTs.

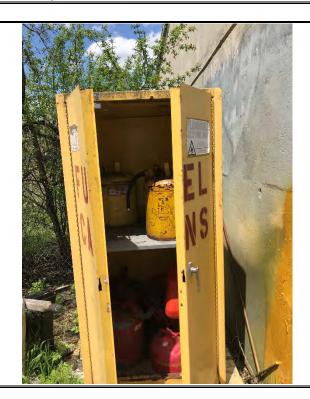
Photo No.	6
Date	5-14-2019
Time	13:19
Direction	northwest
Photo Taken By	RWS

Action Item: Flammables cabinet is located outdoors near the Salt Dome and is corroded. Replace with a new cabinet and place indoors or store under cover.

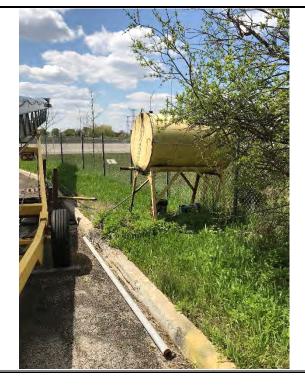
Emulsion AST (near Salt Dome).

Action Item: Relocate the
Asphalt Emulsion Tank on a
paved surface, under cover, with
a drip tray beneath the valve.
Label the tank with tank
contents, storage capacity,
hazards, and warnings.

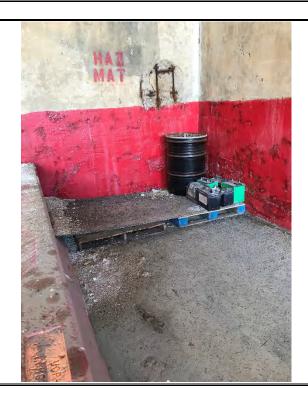
Photo No.	8
Date	5-14-2019
Time	13:28
Direction	northwest
Photo Taken By	RWS

Action Item: Label all waste containers with contents and generation date in the Hazardous Waste Accumulation Area using an adhesive label designed for this purpose.

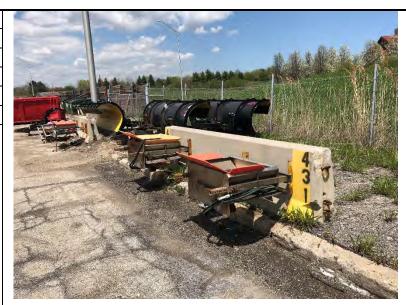
Plow Storage Area, Salt Spreader Storage Area, and Scrap Metal Dumpster Area.

Action Item: Cap and seal the hydraulic lines on plows and salt spreaders.

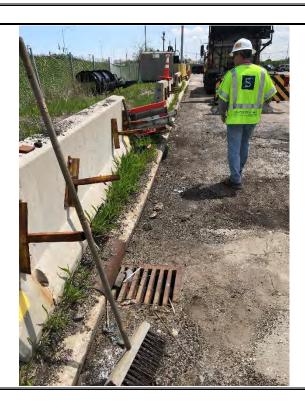
Photo No.	10
Date	5-14-2019
Time	13:33
Direction	south
Photo Taken By	RWS

Parking Area (along east side of facility).

Action Item: Clean the curb line and storm drains of accumulated solids.

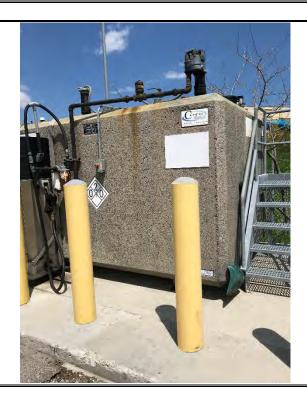
Photo No.	12
Date	5-14-2019
Time	13:36
Direction	east
Photo Taken By	RWS

Replace the faded labels on the Diesel Aboveground Storage Tank. Ensure that legible labels with tank contents, storage capacity, hazards, and warnings are provided.

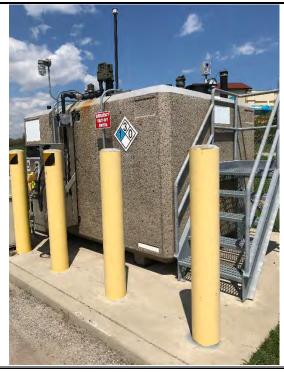
E-85 AST.

Action Item: Replace the faded labels on the E-85 Storage Tank. Ensure that legible labels with tank contents, storage capacity, hazards, and warnings are provided.

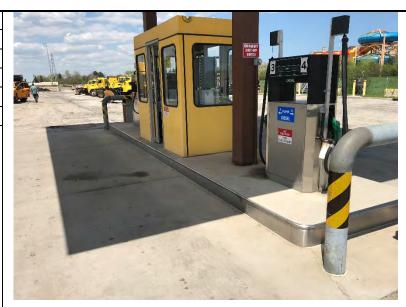
Vehicle Fueling Area.

Action Item: Provide a Spill Kit at the Fuel Island to respond to larger spills and supplement the granular adsorbent currently provided. Label the existing clean adsorbent material container using an adhesive label designed for this purpose.

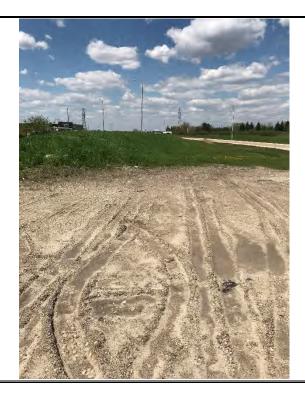
Photo No.	14
Date	5-14-2019
Time	13:40
Direction	north
Photo Taken By	RWS

East Entrance Gate Area.

Action Item: Restore vegetative cover in temporary Contractor staging area near the east entrance gate.

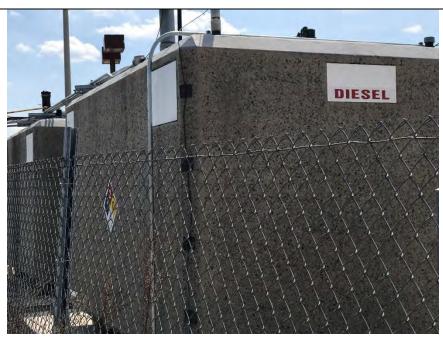
Photo No.	2
Date	5-15-2019
Time	14:40
Direction	West
Photo Taken	RWS

Action Item: Replace the faded labels Aboveground Storage Tanks. Ensure that legible labels with tank contents, storage capacity, hazards, and warnings are provided. Provide a spill kit in fueling area.

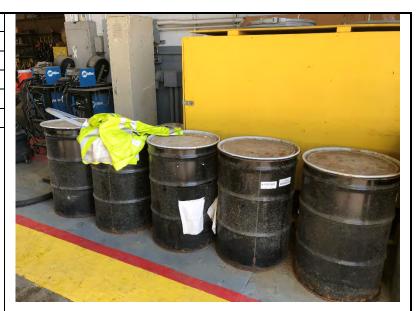
Photo No.	2
Date	5-15-2019
Time	09:05
Direction	south
Photo Taken By	RWS

Action Item: Label all containers with contents and generation date using an adhesive label designed for this purpose.

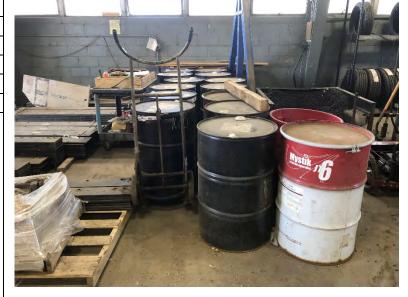
Bulk Oil Storage Area.

Action Item: Label the existing clean adsorbent material container using an adhesive label designed for this purpose.

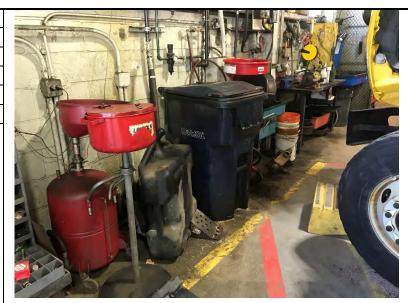
Use Oil/Antifreeze Transfer Area, Used Oil Filter Bin

Action Item: Provide labeling for the Used Oil Filter Bin using an adhesive label designed for this purpose.

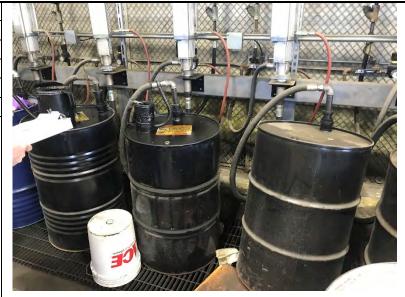
Photo No.	4
Date	5-15-2019
Time	09:09
Direction	north
Photo Taken By	RWS

Bulk Oil Distribution Area.

Action Item: Cleanout the spill containment pit of accumulation fluids.

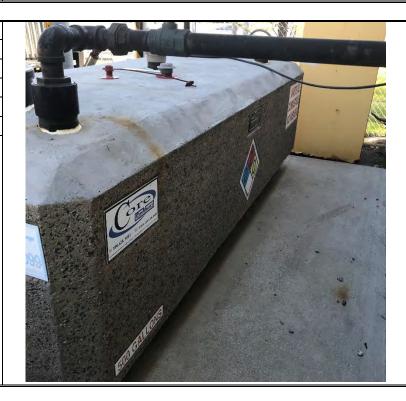
Photo No.	6
Date	5-15-2019
Time	09:11
Direction	north
Photo Taken By	RWS

Used Oil AST.

^{*} Replace the faded labels on the Used Oil AST. Ensure legible labels with tank content, storage capacity, hazards, and warnings are provided. Replace the "Waste Oil" label with "Used Oil" per 40 CFR § 279.22. (see Photo 6)

Action Item: Replace faded labels on the Used Oil AST. Replace "Waste Oil" label with "Used Oil" label per 40 CFR § 279.22.

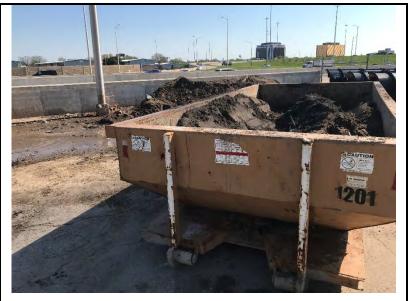
Photo No.	8
Date	5-15-2019
Time	09:14
Direction	north
Photo Taken By	RWS

Sweeper Waste Dumpster.

Action Item: Provide signage for the dumpster contents.

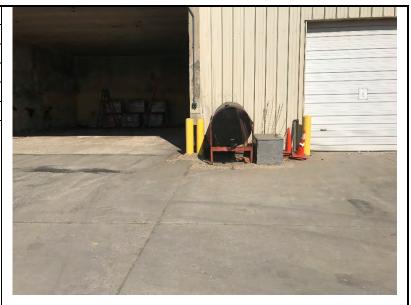
Photo No.	10
Date	5-15-2019
Time	09:18
Direction	west
Photo Taken By	RWS

Emulsion AST.

^{*} The Asphalt Emulsion AST is stored outdoors without cover, is not labeled, and no drip container is provided. Label the tank with contents, storage capacity, hazards, and warnings. Store tank indoors or under cover with a drip tray below the valve. (See Photo 10)

Relocate the Asphalt Emulsion Tank indoors or under cover with a drip tray beneath the valve. Label the tank with tank contents, storage capacity, hazards, and warnings.

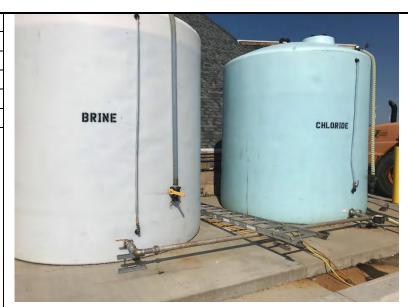
Photo No.	14
Date	5-15-2019
Time	09:27
Direction	east
Photo Taken By	RWS

Action Item: Provide signage with tank content, storage capacity, hazards, and warnings.

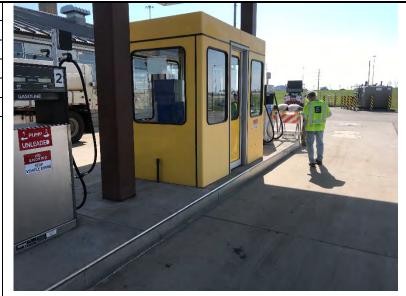
Fuel Island.

Action Item: Provide a spill kit at the Fuel Island to respond to larger spills and supplement the granular adsorbent currently provided. Label the existing clean adsorbent material container using an adhesive label designed for this purpose.

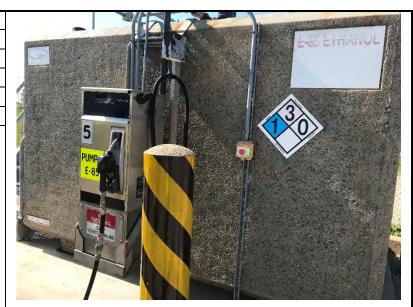
E-85 AST.

Action Items: Replace faded labels on the E-85 Above Ground Storage Tank. Ensure that legible labels with tank content, storage capacity, hazards, and warnings are provided.

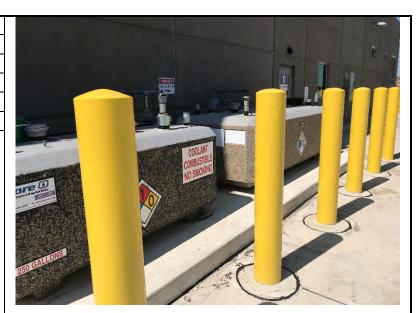
Photo No.	4
Date	5-15-2019
Time	10:44
Direction	east
Photo Taken By	RWS

Action Item: Replace the faded labels on the Used Oil Aboveground Storage Tank. Ensure that legible labels with tank contents, storage capacity, hazards, and warnings are provided. Replace the "Waste Oil" label with "Used Oil" per 40 CFR § 279.22.

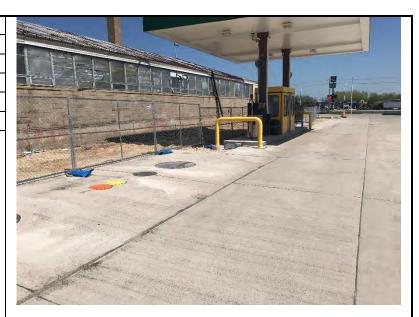
Fuel Island.

Action Item: Provide a Spill Kit at the Fuel Island to respond to larger spills and supplement the granular adsorbent currently provided. Label the existing clean adsorbent material container using an adhesive label designed for this purpose.

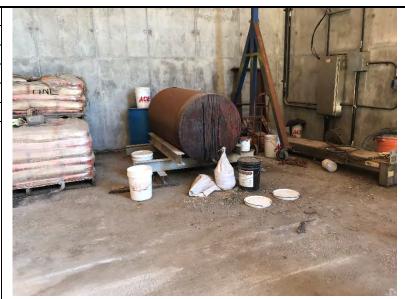
Emulsion AST (inside Salt Dome.)

Action Item: Provide a drip tray beneath the tank valve. Label the tank with tank contents, storage capacity, hazards, and warnings.

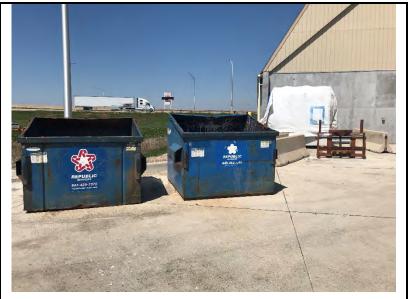
Photo No.	10
Date	5-15-2019
Time	11:05
Direction	west
Photo Taken By	RWS

General Refuse Dumpsters.

^{*} Replace dumpsters with those with covers. (see Photo 10)

Action Item: Provide signage to identify the contents of dumpsters. Replace dumpsters with those with covers.

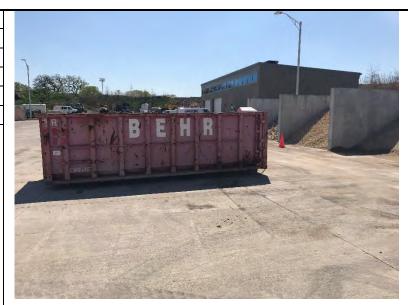
Scrap Metal Dumpster.

Action Item: Provide signage to identify the contents of dumpster.

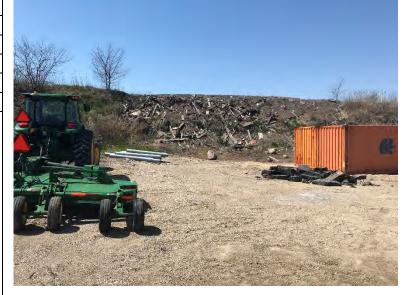
Photo No.	12
Date	5-15-2019
Time	11:13
Direction	south
Photo Taken By	RWS

Earth Berm on south side of facility.

Action Item: Stabilize portion of berm disturbed by Contractor with vegetative cover.

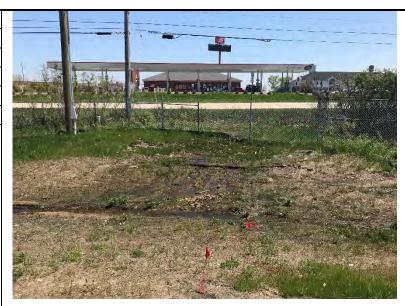
East End of Pond on north side of facility.

Action Item: Stabilize the conveyance where stormwater runoff enters facility from adjacent IDOT right-of-way.

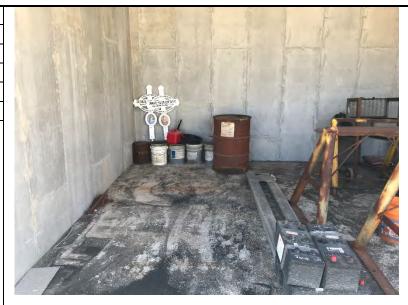
Photo No.	14
Date	5-15-2019
Time	11:15
Direction	South
Photo Taken By	RWS

Hazardous Waste Accumulation Area

Action Item: Label all waste containers with contents and generation date using an adhesive label designed for this purpose

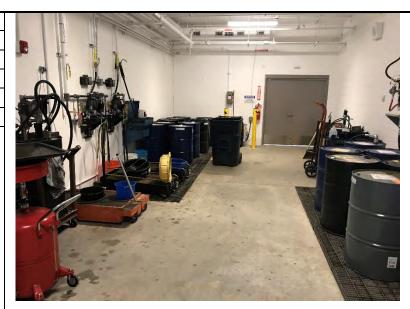
Bulk Oil Storage and Distribution Room.

Action Item: Label the contents for the Used Oil Filter Bin using an adhesive label designed for this purpose.

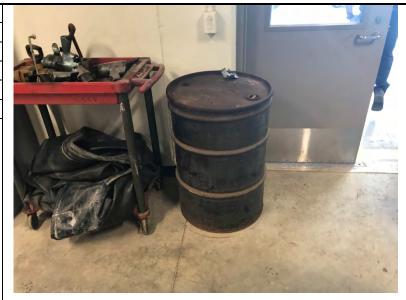
Photo No.	4
Date	5-15-2019
Time	12:20
Direction	east
Photo Taken By	RWS

Clean Oil-Dry Container (in Tire Shop.)

Action Item: Label the contents of the clean adsorbent container using an adhesive label designed for this purpose.

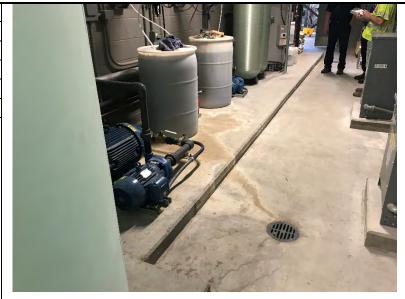
Truck Wash Mechanical Room.

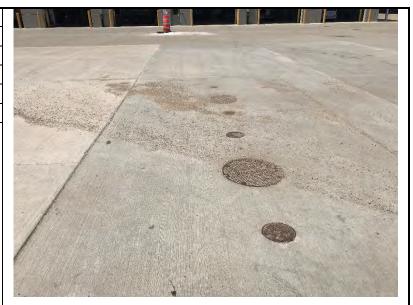
Truck Wash Oil-Water Separator.

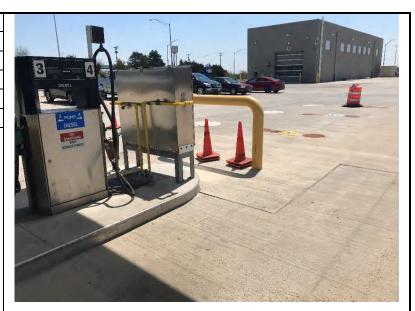
Fueling Island.

Action Item: Provide a spill kit at the Fueling Island to respond to potential larger spills and supplement the granular adsorbent currently provided. Label the existing clean adsorbent container using an adhesive label designed for this purpose.

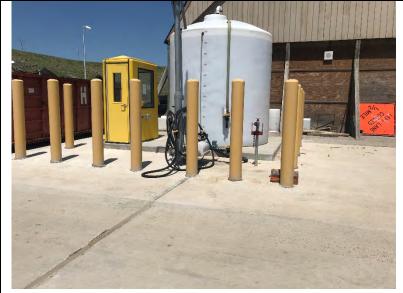
Photo No.	10
Date	5-15-2019
Time	12:32
Direction	north
Photo Taken By	RWS

Chloride Storage Tank.

Action Item: Provide signage for the Calcium Chloride AST including tank contents, storage capacity, hazards, and warnings.

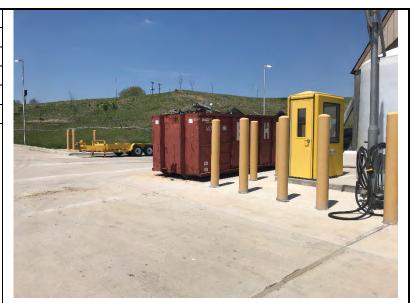
Scrap Metal Dumpster.

Action Item: Provide signage to identify the contents of the dumpster.

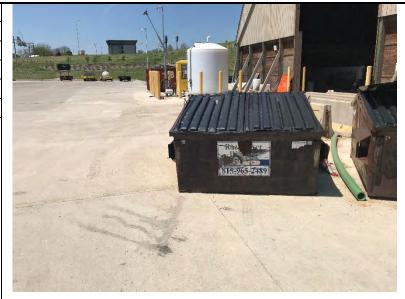
Photo No.	12
Date	5-15-2019
Time	12:35
Direction	west
Photo Taken By	RWS

Municipal Waste Dumpster.

Action Item: Provide signage to identify the contents of dumpsters.

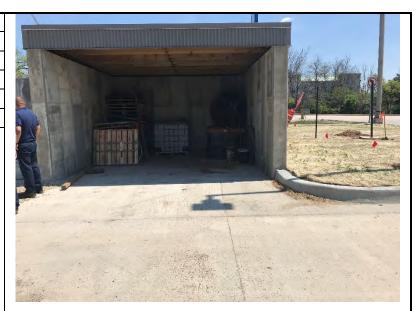
Photo No.	16
Date	5-15-2019
Time	12:42
Direction	north
Photo Taken By	RWS

Action Item: Label all waste containers Hazardous Waste Accumulation Area with contents and generation date using an adhesive label designed for this purpose.

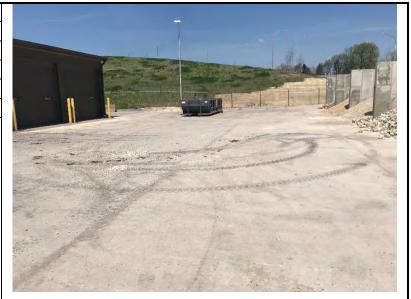
Sweeper Waste Dumpster.

Action Item: Provide signage to identify the contents of dumpster.

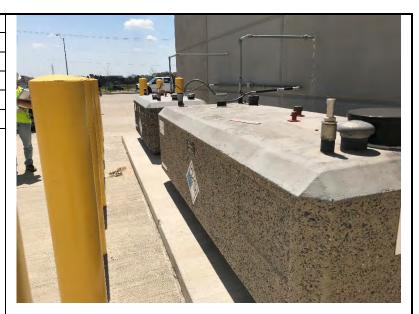
Used Oil and Antifreeze ASTs.

Action Item: Replace the faded labels on the Used Oil AST. Ensure legible labels with tank content, storage capacity, hazards, and warnings are provided. Replace the "Waste Oil" label with "Used Oil" per 40 CFR § 279.22.

^{*} Replace faded labels on the Used Oil Above Ground Storage Tank. Ensure that legible labels with tank content, storage capacity, hazards, and warnings are provided. Replace "Waste Oil" label with "Used Oil" label per 40 CFR § 279.22. (see Photo 23)

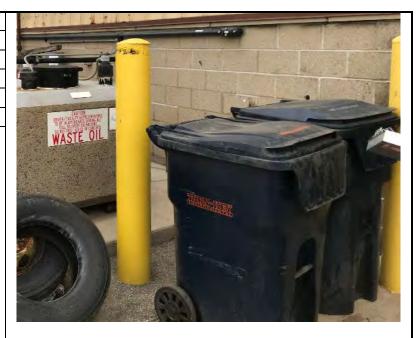
Used Oil Filter Bins.

Action Item: Label the contents for the Used Oil Filter Bins using an adhesive label designed for this purpose.

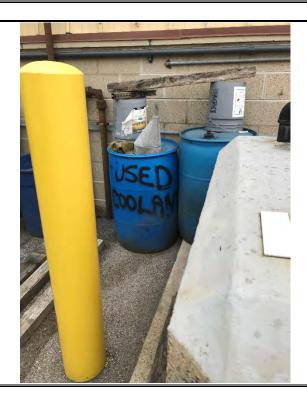
Photo No.	4
Date	5-16-2019
Time	11:39
Direction	north
Photo Taken By	RWS

Action Item: Used coolant drums are not sealed, improperly stored, and are not properly labeled. Relocate drums to store indoors or under cover, seal the bung holes with a proper plug, and label with an adhesive label designed for this purpose.

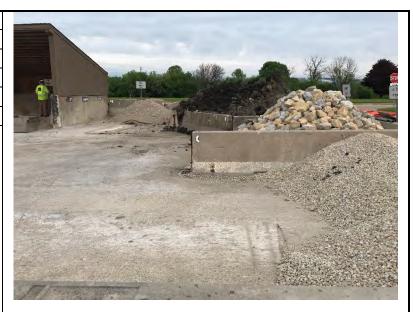
Bulk Material Bunkers.

Action Item: Store topsoil under cover or provide tarp to prevent runoff into stormwater inlets.

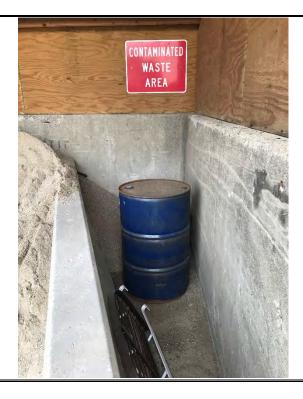
Photo No.	6
Date	5-16-2019
Time	11:40
Direction	north
Photo Taken By	RWS

Hazardous Waste Accumulation Area.

^{*} Label all waste containers in the Hazardous Waste Accumulation Areas with contents and generation date using an adhesive label designed for this purpose. Example labels are attached at the end of this report. (see Photos 6 and 19)

Action Item: Label all waste containers in the Hazardous Waste Accumulation Area with contents and generation date using an adhesive label designed for this purpose.

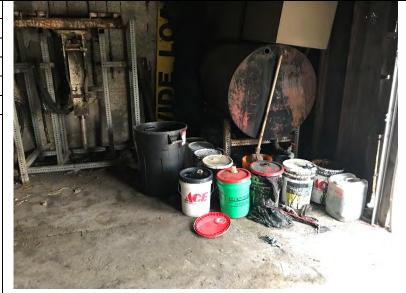
Photo No.	10
Date	5-16-2019
Time	11:50
Direction	north
Photo Taken By	RWS

Emulsion AST inside Storage Building.

^{*} Provide labeling for the Asphalt Emulsion AST including contents, storage capacity, hazards, and warnings. (see Photo 10)

Action Item: The Asphalt Emulsion AST is not labeled. Label the tank with contents, storage capacity, hazards, and warnings.

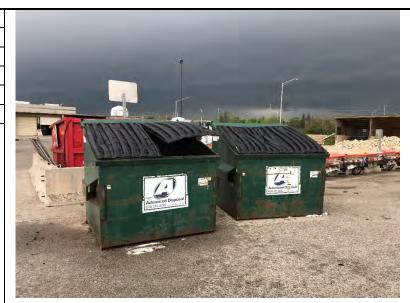
General Refuse Dumpsters.

Action Item: Provide signage to identify the contents of dumpsters.

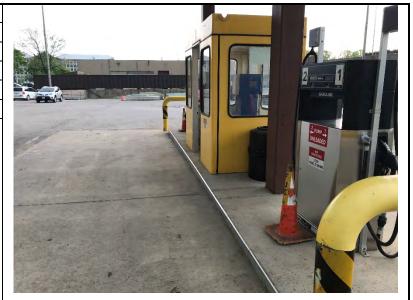
Photo No.	14
Date	5-16-2019
Time	11:57
Direction	east
Photo Taken By	RWS

Fueling Island.

Action Item: Provide a Spill Kit at the Fuel Island to respond to larger spills and supplement the granular adsorbent currently provided. Label the existing clean adsorbent material container using an adhesive label designed for this purpose.

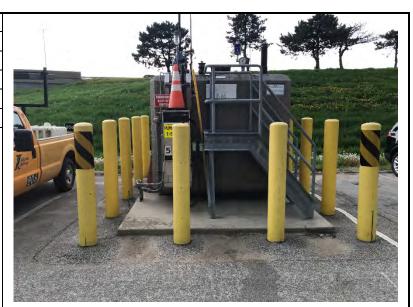
Photo No.	16
Date	5-16-2019
Time	11:57
Direction	east
Photo Taken By	RWS

Action Item: Replace the faded labels on the E-85 Aboveground Storage Tank. Ensure that legible labels with tank contents, storage capacity, hazards, and warnings are provided. Provide a spill kit at the AST.

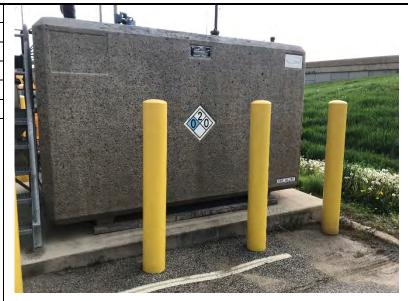
E-85 AST.

^{*} Replace the faded and missing labels on the E-85 Aboveground Storage Tank. Ensure that legible labels with tank contents, storage capacity, hazards, and warnings are provided. Provide a spill kit with adsorbent socks and pads at the AST (see Photos 15 and 16)

Action Item: Replace the missing labels on the E-85 Aboveground Storage Tank. Ensure that legible labels with tank contents, storage capacity, hazards, and warnings are provided. Provide a spill kit at the AST

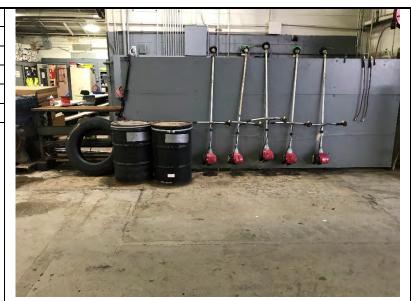
Photo No.	20
Date	5-16-2019
Time	12:03
Direction	south
Photo Taken By	RWS

Action Item: Label all waste containers in the Hazardous Waste Accumulation Area with contents and generation date using an adhesive label designed for this purpose.

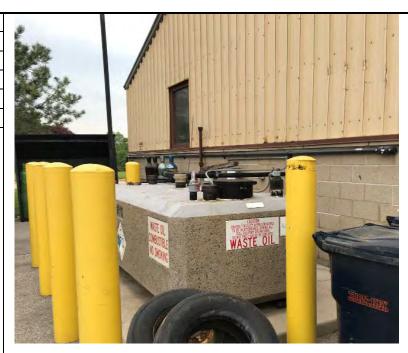
Waste Oil AST.

Action Item: Replace faded labels on the Used Oil Above Ground Storage Tank. Ensure that legible labels with tank content, storage capacity, hazards, and warnings are provided. Replace "Waste Oil" label with "Used Oil" label per 40 CFR § 279.22.

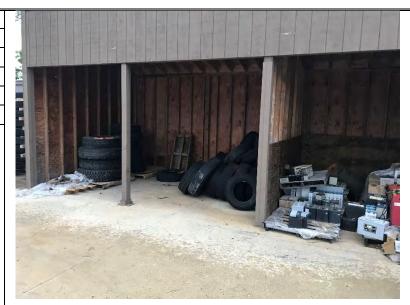
Waste Accumulation Area.

Action Item: The Used Battery Area is overloaded. Arrange for more frequent pickup for recycling and use a portion of the remaining covered storage area for temporary storage until shipped off-site for recycling as needed.

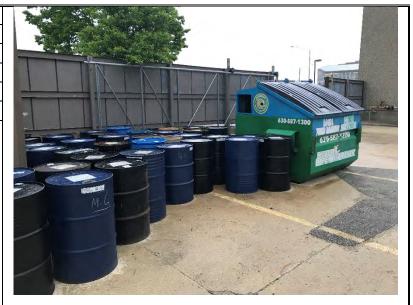
Photo No.	2
Date	5-16-2019
Time	12:10
Direction	north
Photo Taken By	RWS

Empty Drum Accumulation Area and General Refuse Dumpster.

Action Item: Empty drums should be labeled as "EMPTY" using an adhesive label designed for this purpose.

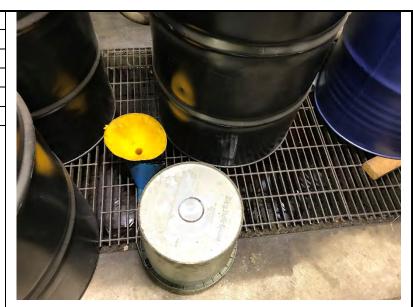
Bulk Oil Storage and Distribution Area.

Action Item: Cleanout the spill containment pit.

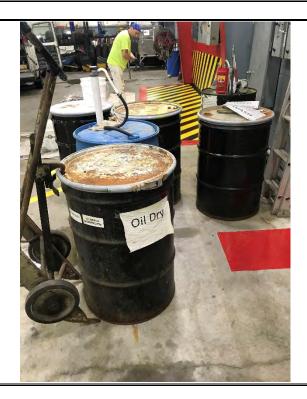
Photo No.	4
Date	5-17-2019
Time	12:51
Direction	south
Photo Taken By	RWS

Hazardous Waste Accumulation Area.

Action Item: Label all containers with contents and generation date using an adhesive label designed for this purpose.

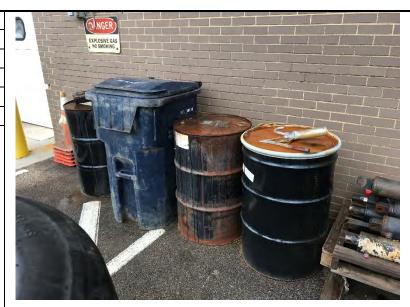
Used Oil Filter Bin Area.

Action Item: Provide labeling for the Used Oil Filter Bin. Label empty drums as "EMPTY" using an adhesive labeled designed for this purpose and arrange for recycling if the drums are not to be re-used.

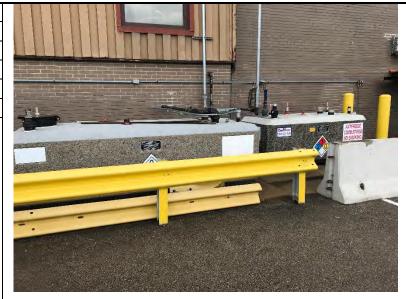
Photo No.	6
Date	5-17-2019
Time	12:58
Direction	north
Photo Taken By	RWS

Used Oil and Antifreeze ASTs.

Replace the faded labels on the tank. Ensure that legible labels with tank content, storage capacity, hazards, and warnings are provided. Replace "Waste Oil" label with "Used Oil" label per 40 CFR § 279.22.

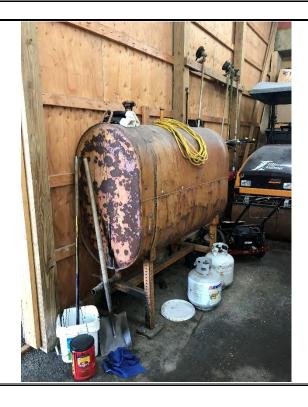
Photo No.	8
Date	5-17-2019
Time	13:04
Direction	west
Photo Taken By	RWS

Emulsion AST (inside Salt Dome Garage.)

Action Item: Provide labeling for the tank including contents, capacity, hazards, and warnings.

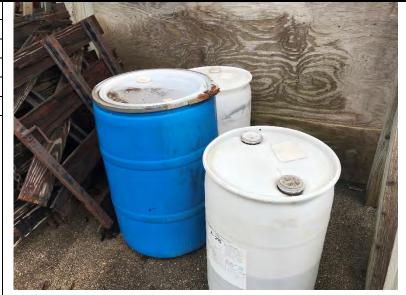
Photo No.	10
Date	5-17-2019
Time	13:12
Direction	east
Photo Taken By	RWS

Equipment Storage Area (west side of the Salt Dome).

Label empty drums as "EMPTY" using an adhesive label designed for this purpose and arrange for recycling if the drums are not to be re-used.

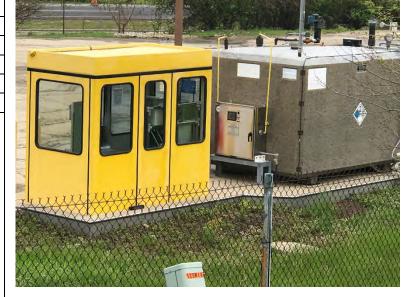
Photo No.	2
Date	5-17-2019
Time	14:14
Direction	south
Photo Taken By	RWS

Diesel AST.

Action Item: Provide a spill kit for the fueling area. Replace the faded labels on the diesel aboveground storage tank. Ensure that labels with tank content, storage capacity, hazards, and warnings are provided.

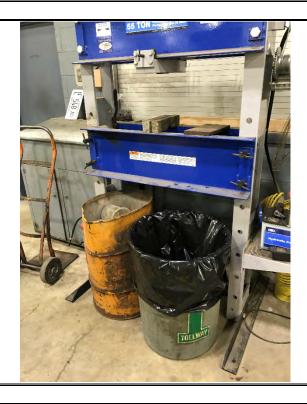
New Oil-Dry Container (inside Maintenance Building).

Action Item: Label the contents of the clean adsorbent container in the Vehicle Maintenance Area using an adhesive label designed for this purpose.

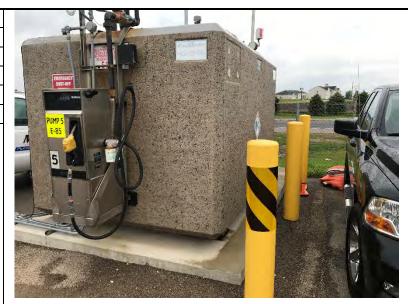
Photo No.	6
Date	5-17-2019
Time	09:02
Direction	south
Photo Taken By	RWS

Action Item: Replace the faded labels on the E-85 AST. Ensure that legible labels with tank content, storage capacity, hazards, and warnings are provided.

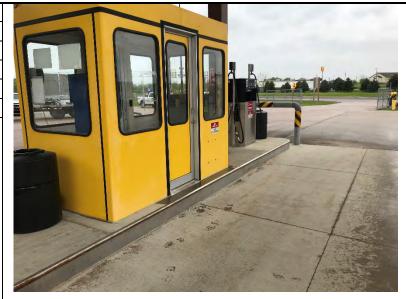
Fuel Island.

Action Item: Provide a spill kit at the Fueling Island to respond to potential larger spills and supplement the granular adsorbent currently provided. Label the existing clean adsorbent container using an adhesive label designed for this purpose.

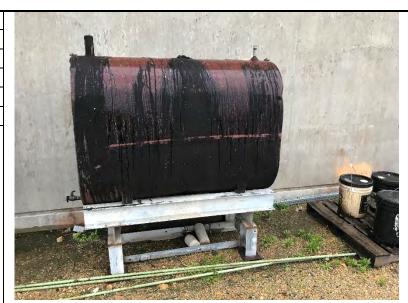
Photo No.	8
Date	5-17-2019
Time	09:08
Direction	north
Photo Taken By	RWS

Action Item: The Asphalt Emulsion Tank is not labeled. Label the tank with contents, storage capacity, hazards, and warnings. Provide a drip pan under the tank valve. Store tank indoors or under cover.

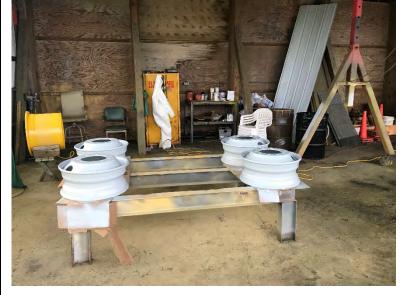
Painting Area (inside Salt Dome Shop Area.)

Action Item: Label all hazardous waste containers with contents and generation date using an adhesive label designed for this purpose.

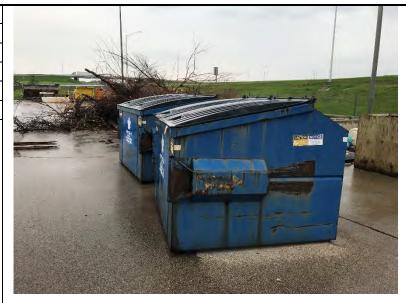
Photo No.	10
Date	5-17-2019
Time	09:13
Direction	east
Photo Taken By	RWS

Municipal Waste Dumpsters.

Action Item: Provide signage to identify the contents of dumpsters.

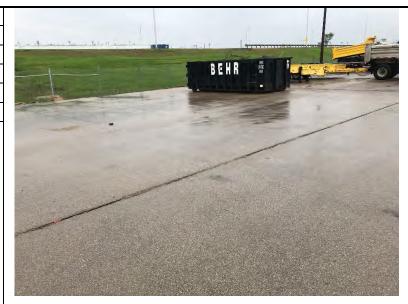
Scrap Metal Dumpster.

Action Item: Provide signage to identify the contents of dumpster.

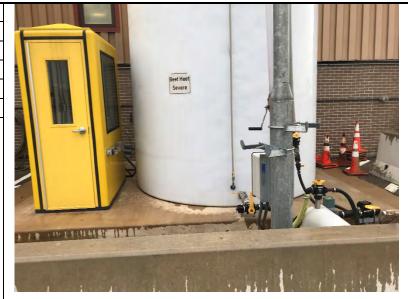
Photo No.	12
Date	5-17-2019
Time	09:14
Direction	north
Photo Taken By	RWS

Salt Brine AST.

^{*} Provide signage for the Salt Brine AST. Ensure that legible labels with tank content, storage capacity, hazards, and warnings are provided. (see Photo 12)

Action Item: Provide signage for the Salt Brine AST. Ensure that legible signage with tank content, storage capacity, hazards, and warnings are provided.

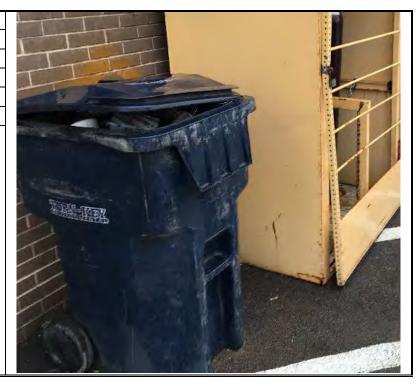
Used Oil Filter Bin.

Action Item: Label the contents for the Used Oil Filter Bin using an adhesive label designed for this purpose.

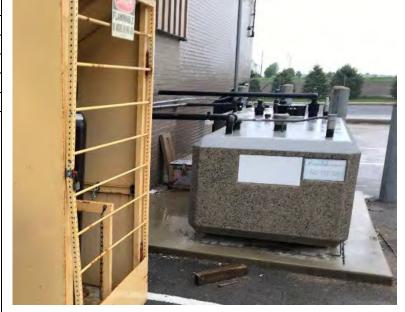
Photo No.	14
Date	5-17-2019
Time	09:16
Direction	north
Photo Taken By	RWS

Used Oil and Antifreeze ASTs.

^{*} Replace the faded labels on the Used Oil AST. Ensure that legible labels with tank content, storage capacity, hazards, and warnings are provided. Replace the "Waste Oil" label with "Used Oil" per 40 CFR § 279.22. (see Photo 14)

Action Item: Replace the faded labels on the Used Oil AST. Ensure that legible labels with tank content, storage capacity, hazards, and warnings are provided. Replace the "Waste Oil" label with "Used Oil" per 40 CFR § 279.22.

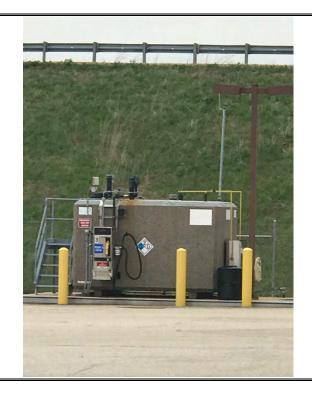
Diesel AST.

^{*} Provide a spill kit with adsorbent socks and pads for the fueling area. Replace the faded labels on the diesel Aboveground Storage Tank. Ensure that labels with tank contents, storage capacity, hazards, and warnings are provided. (see Photo 1)

Action Item: Provide a spill kit for the fueling area. Replace the faded labels on the diesel aboveground storage tank. Ensure that labels with tank contents, storage capacity, hazards, and warnings are provided.

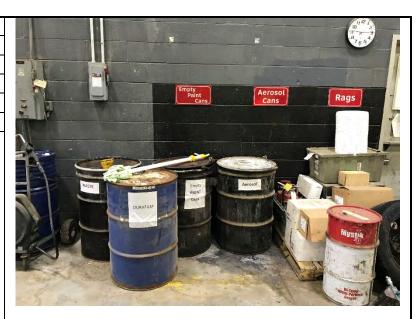
Hazardous Waste Accumulation Area.

Action Item: Label all waste containers with contents and generation date using an adhesive label designed for this purpose.

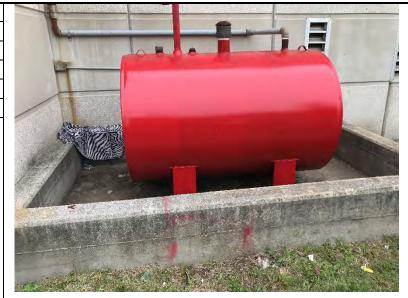
Photo No.	4
Date	5-16-2019
Time	09:19
Direction	east
Photo Taken By	RWS

Used Oil AST.

Action Item: Provide labeling for the Used Oil Aboveground Storage Tank. Ensure that legible labels with tank contents, storage capacity, hazards, and warnings are provided.

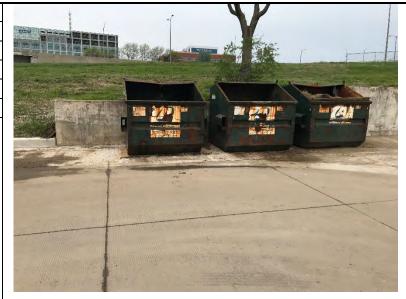
Photo No.	6
Date	5-16-2019
Time	09:24
Direction	west
Photo Taken By	RWS

Municipal Waste Dumpsters.

^{*} Replace dumpsters with those with covers. (see Photo 6)

Action Items: Provide signage to identify the contents of dumpsters. Replace dumpsters with those with covers.

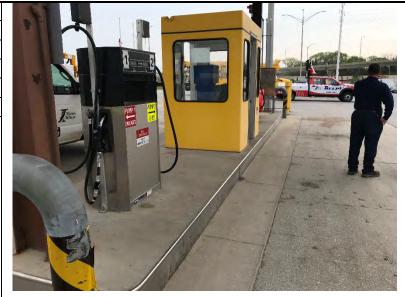
Photo No.	8
Date	5-16-2019
Time	09:27
Direction	east
Photo Taken By	RWS

Fuel Island.

Action Item: Provide a Spill Kit at the Fuel Island to respond to larger spills and supplement the granular adsorbent currently provided. Label the existing clean adsorbent material container using an adhesive label designed for this purpose.

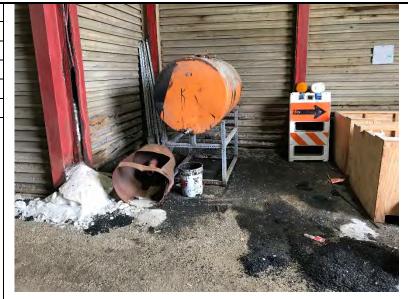
Photo No.	10
Date	5-16-2019
Time	09:32
Direction	north
Photo Taken By	RWS

Asphalt Emulsion Tank (inside Salt Dome.)

Action Item: Label the tank with tank contents, storage capacity, hazards, and warnings.
