Move Illinois: The Illinois Tollway Driving the Future

Municipal Annual Storm Water Inspection Report

NPDES Permit No. ILR400494 for Discharges from MS4s

Illinois Tollway NPDES Permit No. ILR400494 Reporting Period: March 2019 to March 2020

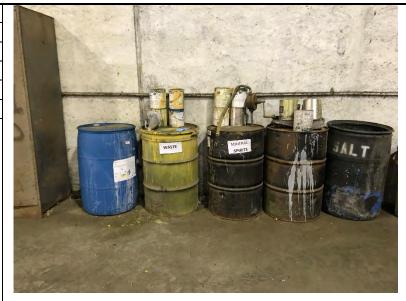
Photo No.	12
Date	5-16-2019
Time	09:35
Direction	south
Photo Taken By	RWS

Painting Area.

Action Item: Label all waste containers with contents and generation date using an adhesive label designed for this purpose.

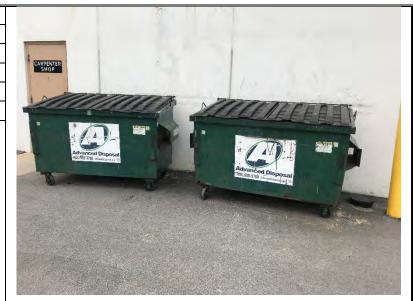
Municipal Waste Dumpsters at Central Garage.

Action Item: Provide signage to identify the contents of dumpsters.

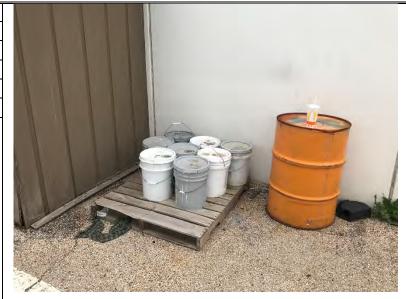
Photo No.	2
Date	5-16-2019
Time	10:21
Direction	north
Photo Taken By	RWS

Outside Southeast Corner of Central Garage Building.

Action Item: Empty drums should be labeled "EMPTY" using an adhesive label designed for this purpose and arrange for recycling. Paint materials should be stored inside or under cover. All containers should be properly labeled.

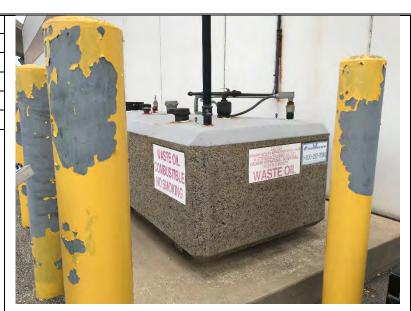
Used Oil AST at Central Garage.

Action Item: Replace the faded labels on the Used Oil AST. Ensure legible labels with tank content, storage capacity, hazards, and warnings are provided. Replace the "Waste Oil" label with "Used Oil" per 40 CFR § 279.22.

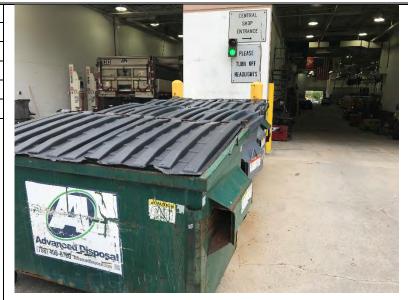
Photo No.	6
Date	5-16-2019
Time	10:30
Direction	east
Photo Taken By	RWS

Municipal Waste Dumpsters at Central Garage.

Action Item: Provide signage to identify the contents of dumpsters.

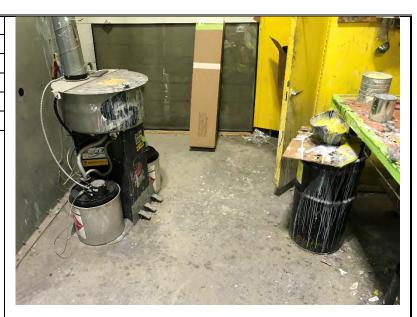
Painting Area (inside Body Shop) at Central Garage.

Label all waste containers with contents and generation date using an adhesive label designed for this purpose.

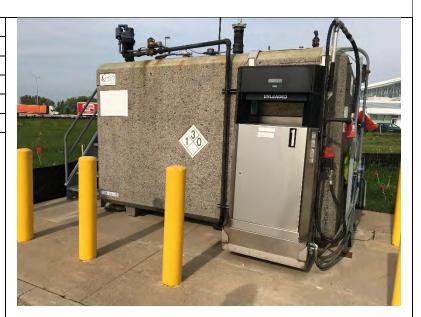
Unleaded Gasoline AST.

Action Item: Replace the faded labels on the Gasoline Aboveground Storage Tank. Ensure that legible labels with tank contents, storage capacity, hazards, and warnings are provided.

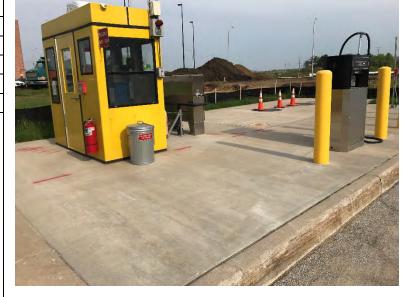
Photo No.	2
Date	5-16-2019
Time	08:27
Direction	west
Photo Taken By	RWS

Diesel UST Area.

Action Item: Provide a Spill Kit at the Fueling Area to respond to larger spills and supplement the granular adsorbent currently provided.

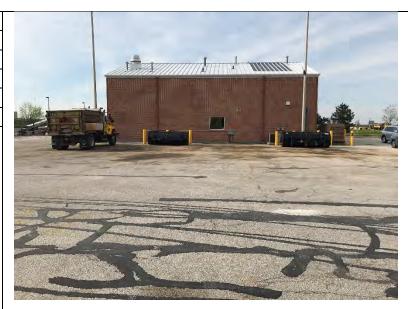
Truck Parking Area.

Action Item: Clean areas of hydraulic oil spills using adsorbent and the pavement cleaned using an enzyme or biodegradable cleaner.

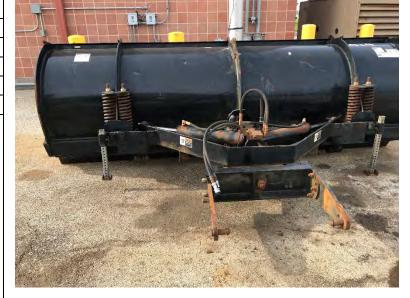
Photo No.	4
Date	5-16-2019
Time	08:31
Direction	south
Photo Taken By	RWS

Truck Parking Area.

Action Item: The hydraulic lines on plows should be capped and sealed to prevent spills.

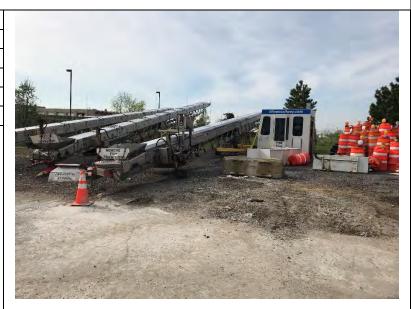
Equipment Storage Area.

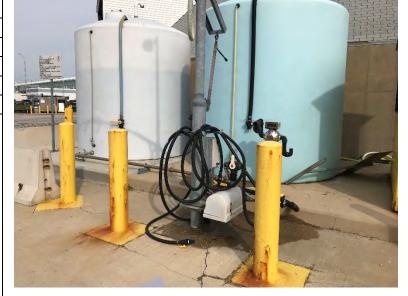
Photo No.	6
Date	5-16-2019
Time	08:34
Direction	north
Photo Taken By	RWS

CALCIUM CHLORIDE ABOVEGROUND STORAGE TANK (IF APPLICABLE)		(Select One)
1	Is the calcium chloride AST area free of leaks, stains, spills?	No
2	Are the pump and hoses in good condition (no cracks, etc)?	Yes
3	Are the AST valves in the closed position when not in use?	Yes

BEET HEAT/SALT BRINE ABOVGROUND STORAGE TANK (IF APPLICABLE)		(Select One)
1	Tank Contents: Beet Heat/Salt Brine	Salt Brine
2	Is the AST area free of leaks, stains, spills?	No
3	Are the pump and hoses in good condition (no cracks, etc)?	Yes
4	Are the AST valves in the closed position when not in use?	Yes

Salt Brine and Calcium Chloride Storage Tanks.

- * Repair the anchors for the tank signage which has been knocked over/fasteners snapped. (see Photo 6)
- * Repair the small leak observed at the tank valves. (see Photo 6)

^{*} Repair the small leak observed at the tank valves. (see Photo 6)

Action Item: Repair the anchors for the tank signage which has been knocked over/fasteners snapped. Repair the small leak observed at the tank valves.

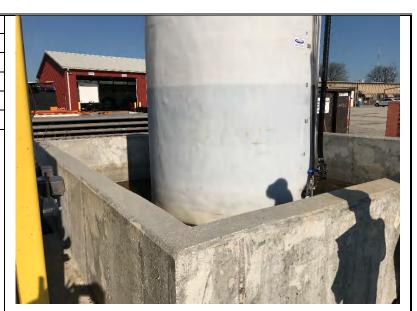
Salt Brine AST.

^{*} Provide signage for the Salt Brine AST. Ensure that signage with tank contents, storage capacity, hazards, and warnings are provided. (see Photo 1)

Action Item: Provide signage for the Salt Brine AST. Ensure that signage with tank content, storage capacity, hazards, and warnings are provided.

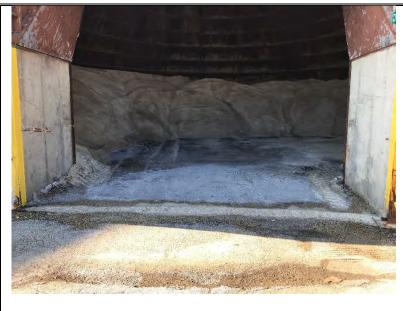
Photo No.	2
Date	5-15-2019
Time	08:18
Direction	south
Photo Taken By	RWS

Salt Dome.

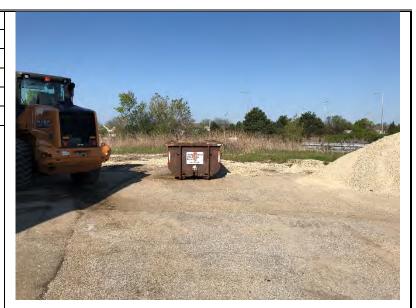
Sweeper Waste Dumpster.

Action Item: Provide signage for the dumpster contents.
